Inspection Report

Property Services Group WA

Dianella, WA, Australia

Building Inspection

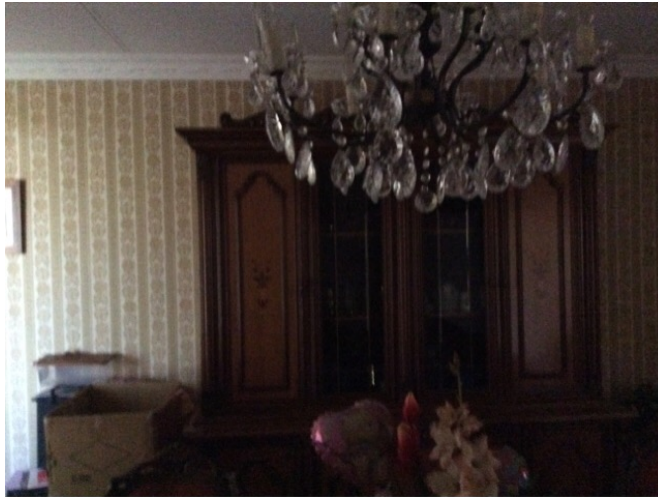
Possible concealment of wall cracks

Wall paper exists to lounge room wall

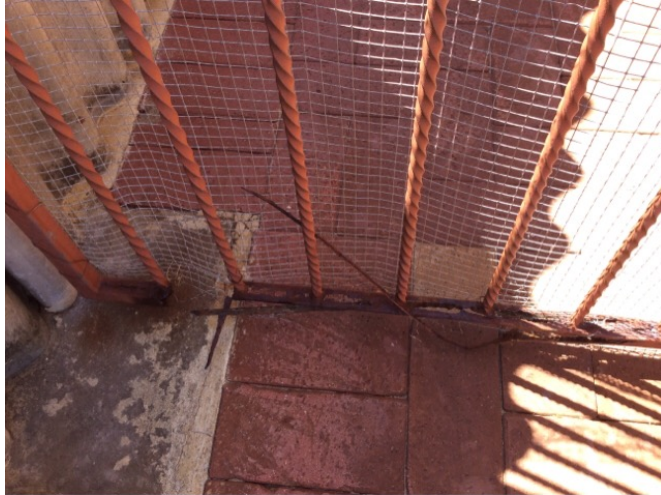
Rust Noted To Gates. Replacement Recommended.

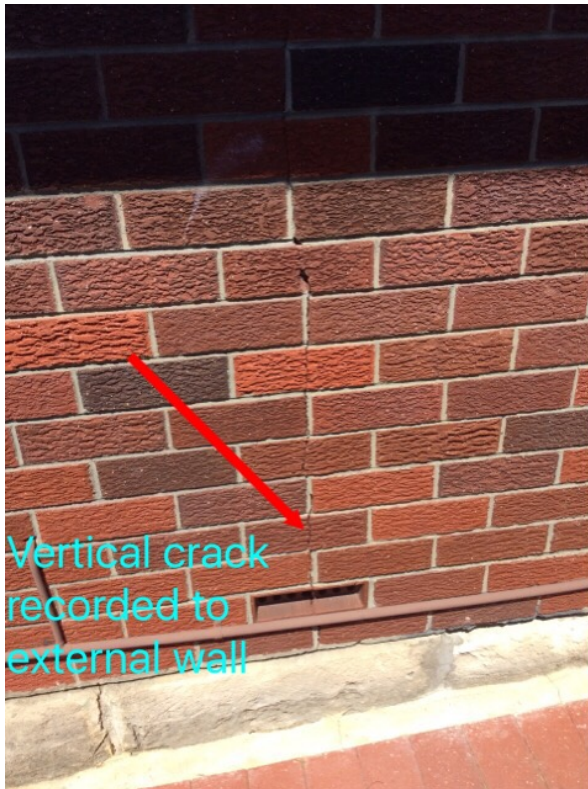
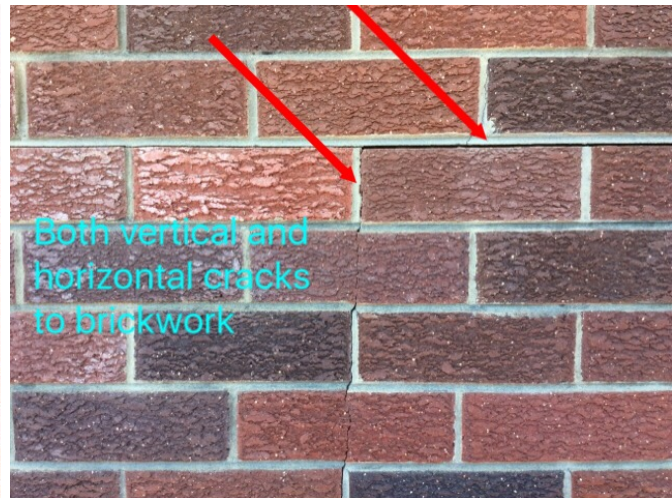
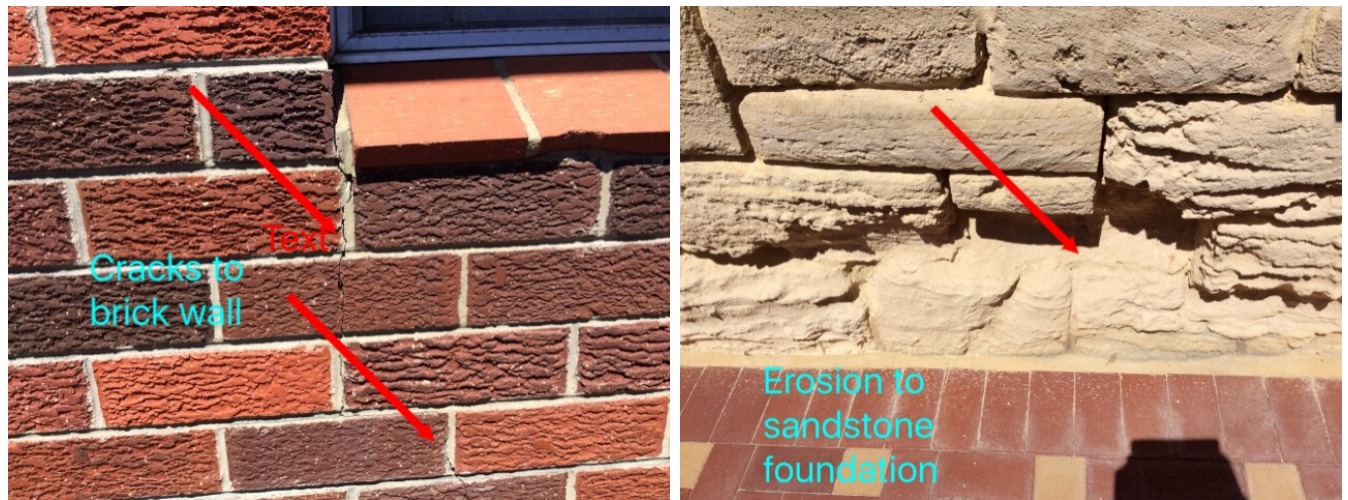
Cracks noted. Possible causes may be foundation movement. Support structure deflection, tree roots, possible ground movement due to compaction to sand pad prior to slab pour to new proposed building next door . Thermal movement and moisture uptake or loss, failure under external loads. A structural engineer should be consulted for further evaluation and advice.

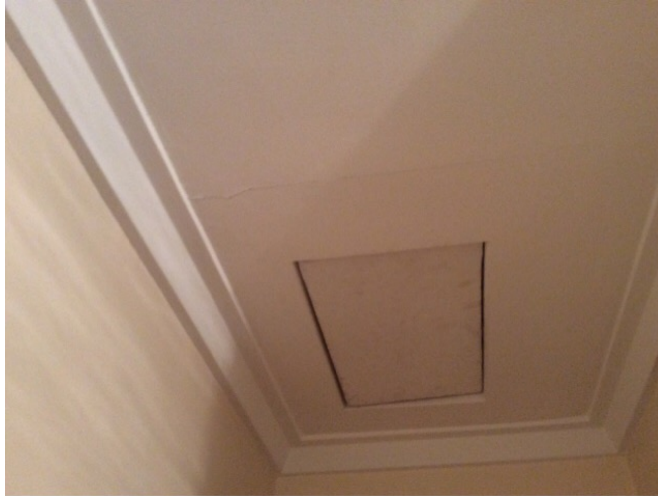
Settlement Cracks Noted . These are typical and generally patch and paint will suffice, however Monitoring these cracks advised for 12 months and if become wider or longer, you will need to contact a structural engineers to assess.

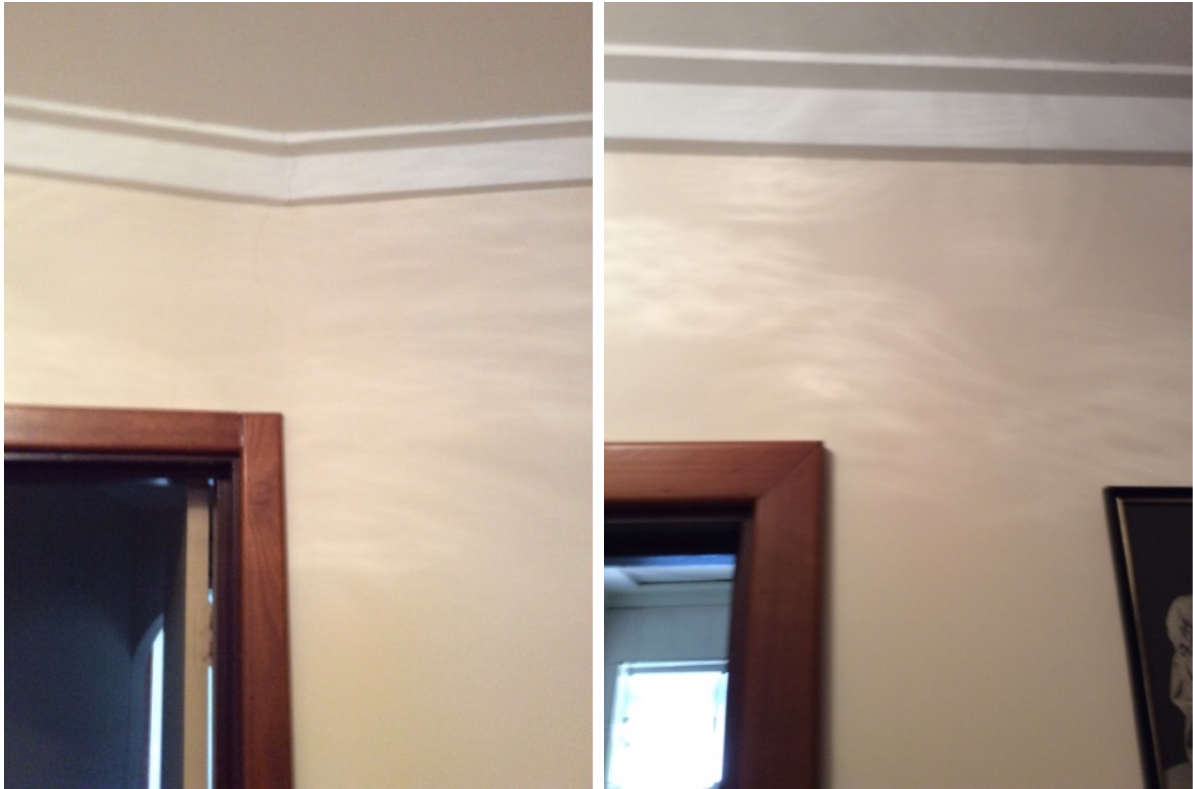
Settlement Cracks Noted . These are typical and generally patch and paint will suffice, however Monitoring these cracks advised for 12 months and if become wider or longer, you will need to contact a structural engineers to assess.

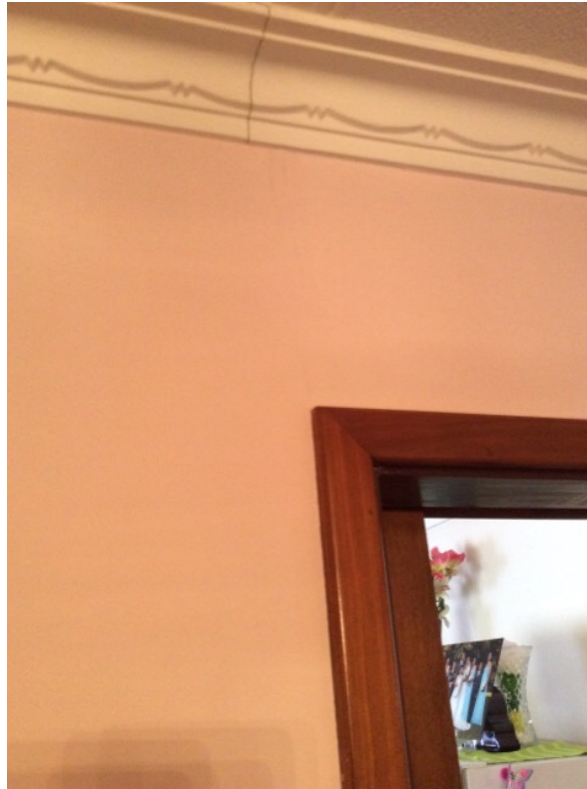
Settlement Cracks Noted . These are typical and generally patch and paint will suffice, however Monitoring these cracks advised for 12 months and if become wider or longer, you will need to contact a structural engineers to assess.

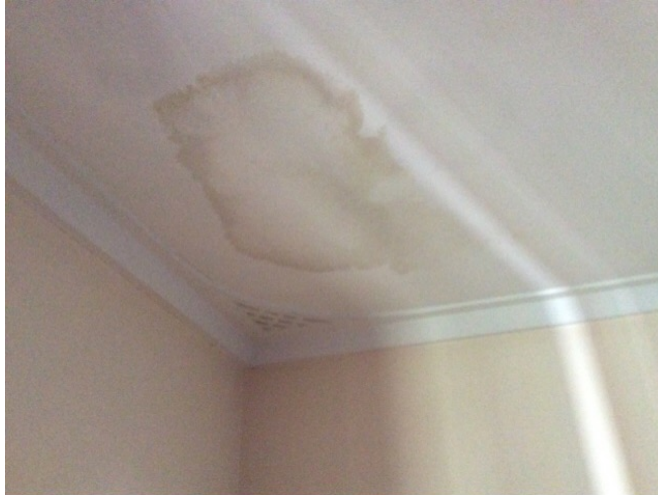
Ceiling stains - No moisture readings obtained. Recommendations: These may have been repaired, however, you will need to monitor after a prolonged period of rainfall - If leaking persists, a qualified plumber should be engaged for advice and recommendations. All water damaged plaster replaced by a qualified plasterer.

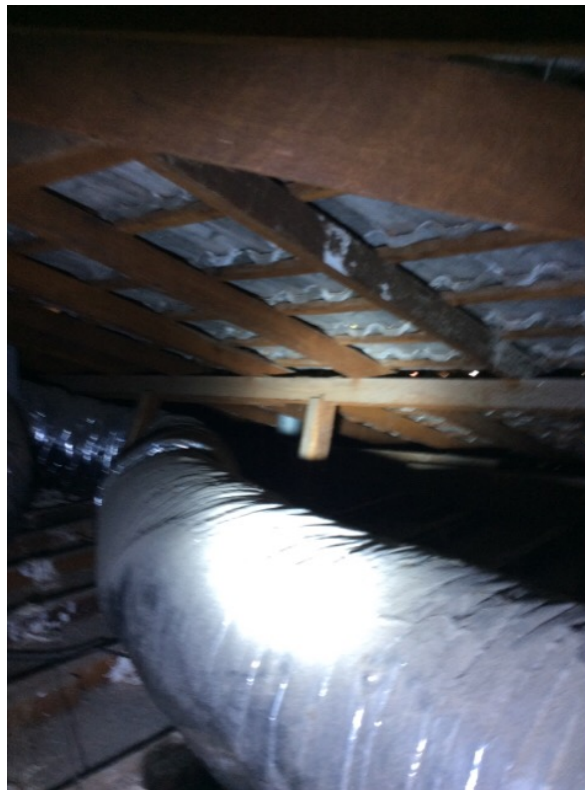
There is heating and/or cooling ducting present in the roof space/void. This is preventing a full inspection from being undertaken. It is strongly recommended that full access be gained as it could be harbouring timber pest activity, damage or defects.

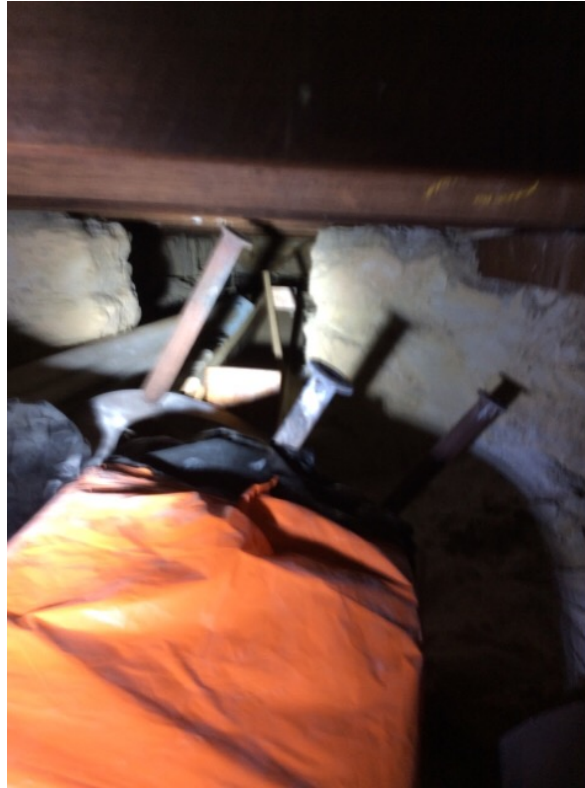
Low access restricted full visual inspection.

Stored items restricted visual inspection.
