# Inspection Report

## Inspection Address

**17 Grainger way thornlie, Perth, Wa, 6108**

## TIMBER PEST INSPECTION

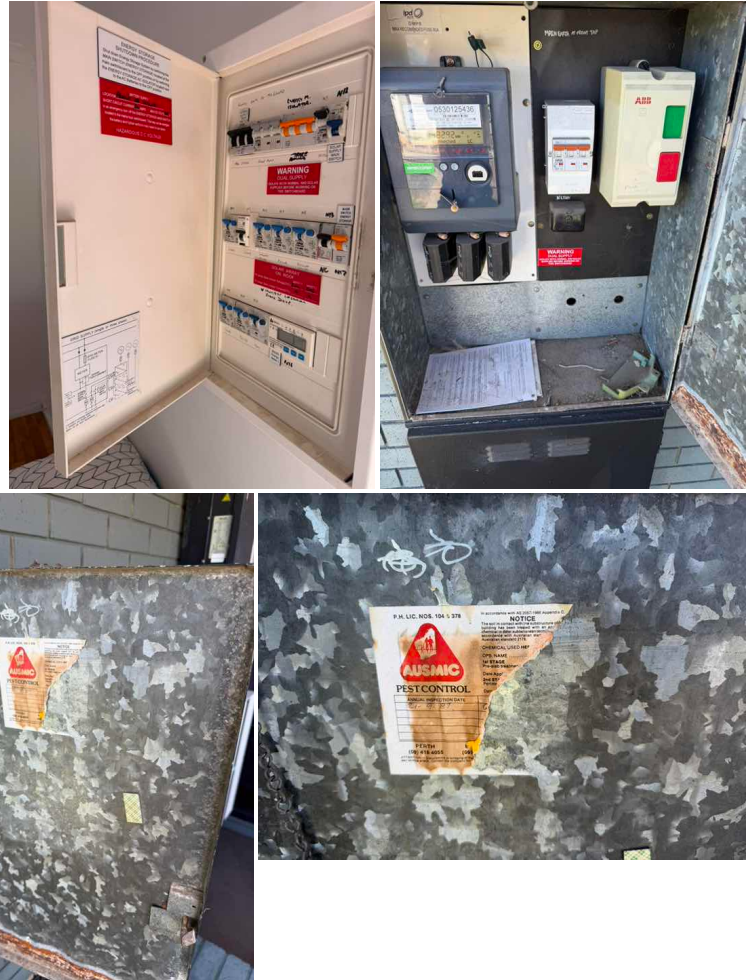
Yes, a durable notice was found in the meter-box during the inspection it was damaged unable to gain any information from the sticker other than a date

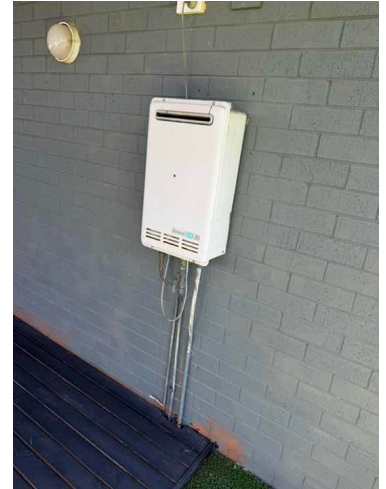
Not applicable to this type of hot water system.

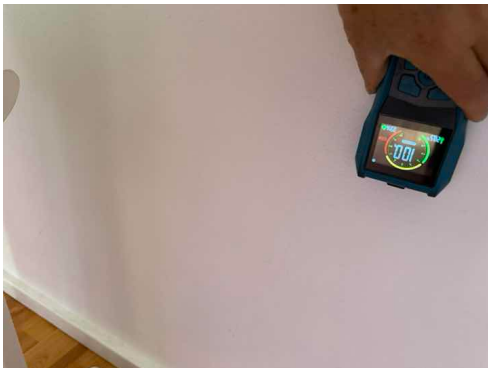
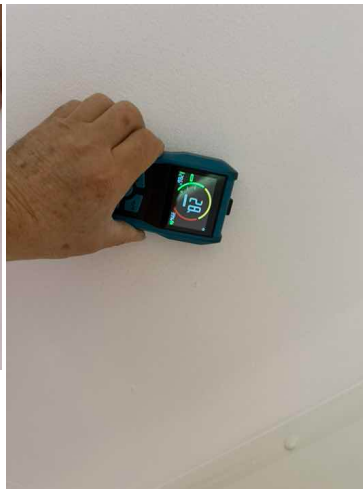
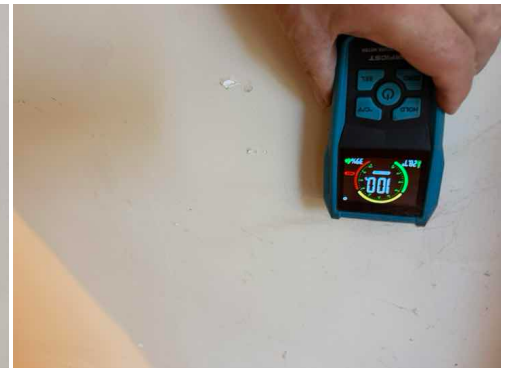
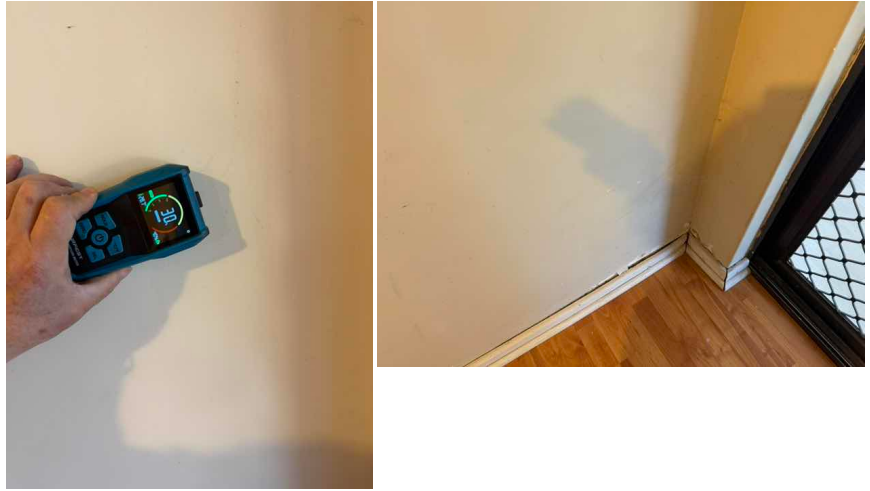
Moisture Readings – Adjacent to Shower Recess

Moisture meter readings were taken to wall surfaces adjacent to the shower recess and elevated readings were noted at the time of inspection. Moisture meter testing is non-invasive and provides indicative readings only. No dismantling, removal of finishes or invasive testing has been undertaken. The source and extent of the moisture cannot be determined within the limitations of a visual inspection. Moisture may be associated with typical wet area use, sealant deterioration or waterproofing performance. If concerns persist or if visible deterioration becomes evident over time, further assessment by a suitably qualified tradesperson is recommended.

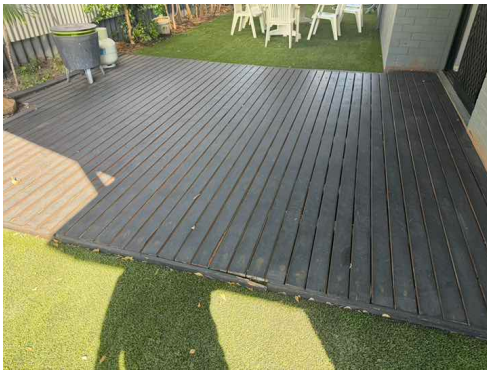
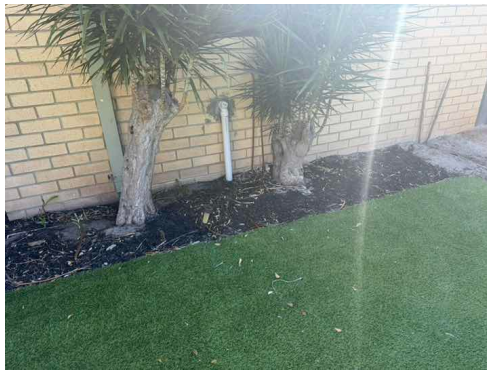
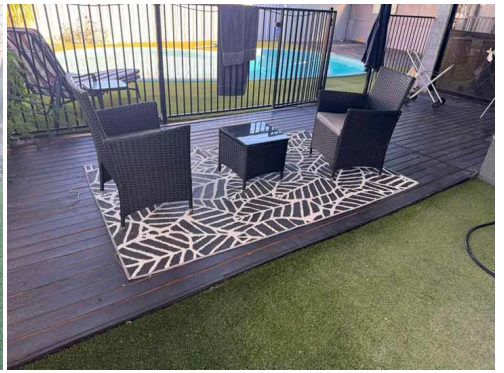
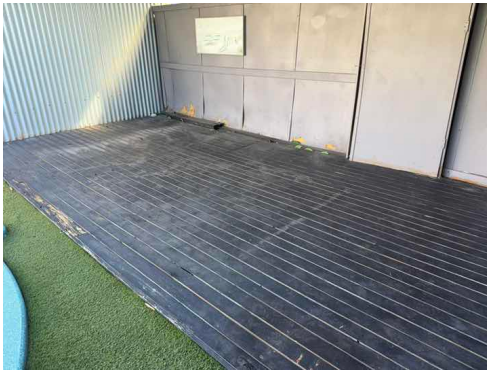
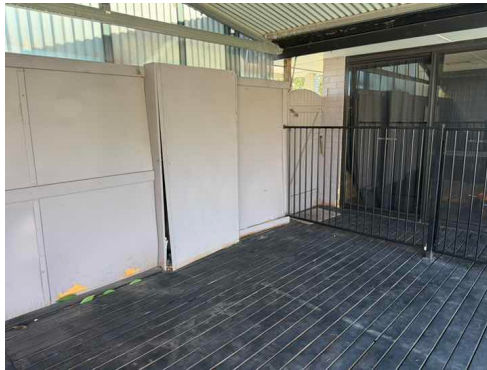
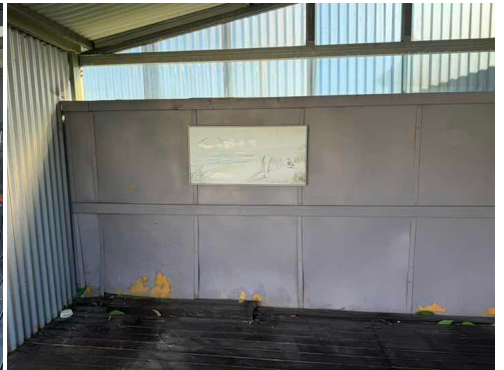
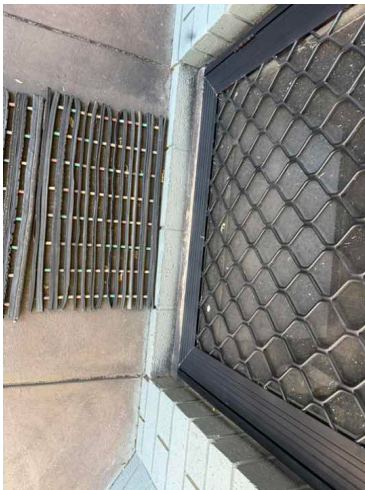
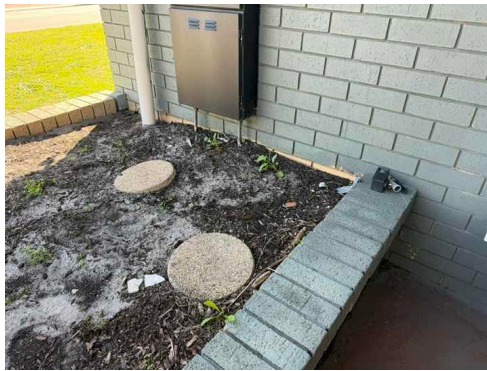
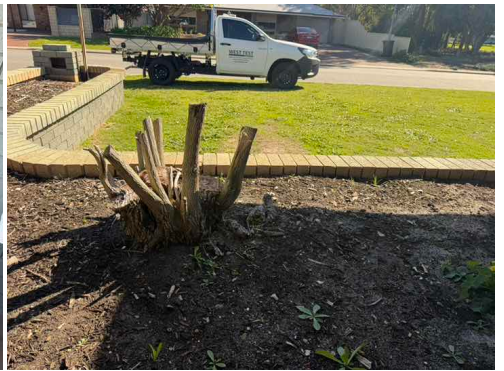
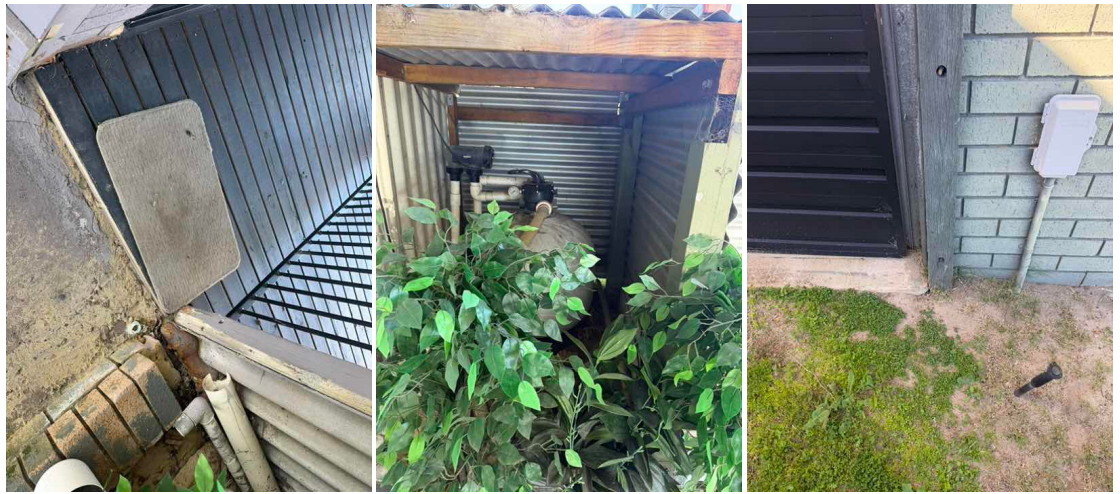
Timber in contact with ground. This provides conducive and concealed conditions and concealed entry for termite infestation.

Tree stump/s are located at the site. These need to be removed by a suitably qualified tradesperson as they are conducive conditions for a termite nest.

Tree/leafy environment: This property is located in a suburb which is high risk due to the environmental surrounds. It is close to large trees and parkland. A termite management plan/treatment is strongly advised.

These garden beds should be reduced, relocated or modified to minimise termite conducive conditions.
