# Inspection Report

**Property Services Group WA Pty Ltd T/A Building & Pest Services WA**

**17 Grainger way thornlie, Perth, Wa, 6108**

| Report/Agreement # | 290726012827506 |

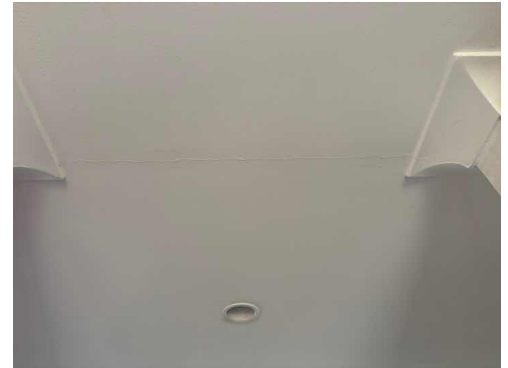
Settlement Cracks Noted. These are typical and generally patch and paint will suffice, however monitoring these cracks is advised for 12 months and if they become worse, further investigation by a suitably qualified professional is advised.

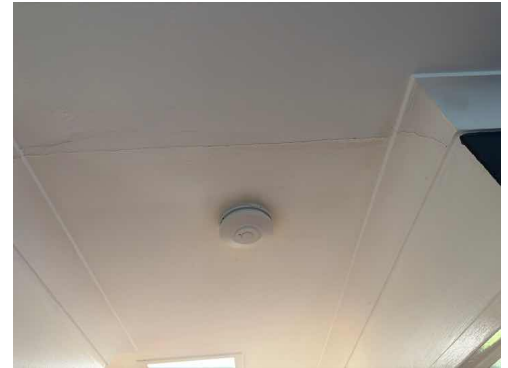
Settlement Cracks Noted. These are typical and generally patch and paint will suffice, however monitoring these cracks is advised for 12 months and if they become worse, further investigation by a suitably qualified professional is advised.

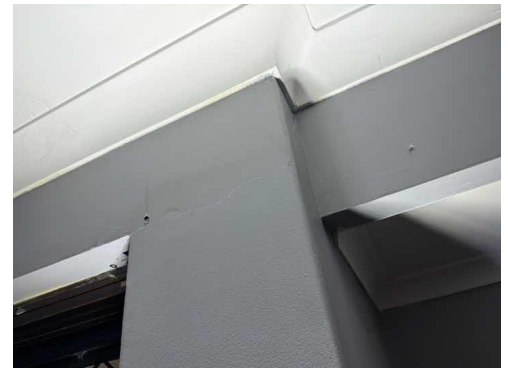
Settlement Cracks Noted. These are typical and generally patch and paint will suffice, however we recommend you monitor these cracks and if they become wider or longer, you will need to contact a structural engineers to assess.

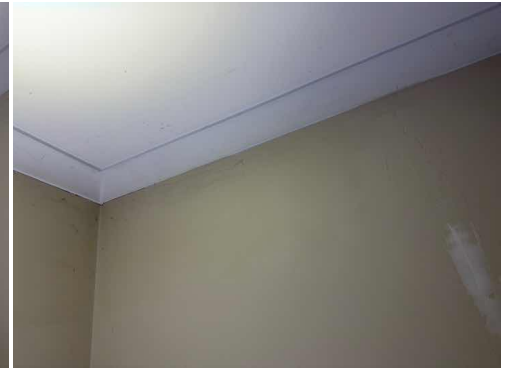
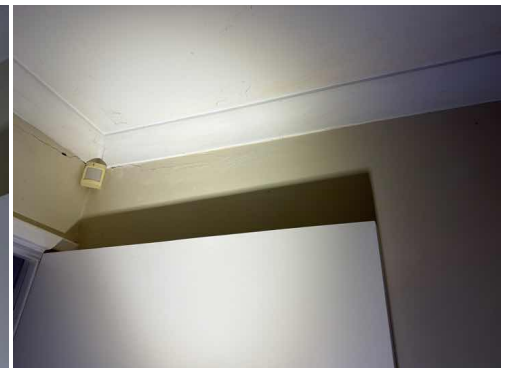
Settlement Cracks Noted. These are typical and generally patch and paint will suffice, however we recommend you monitor these cracks and if they become wider or longer, you will need to contact a structural engineers to assess.

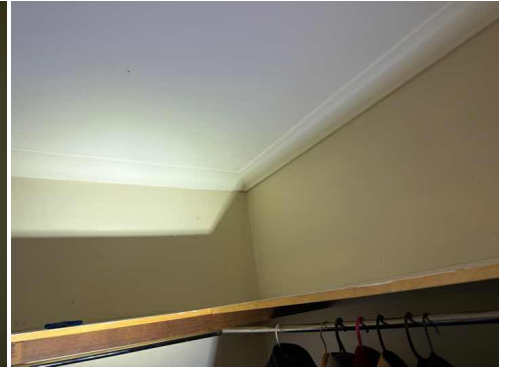
Settlement Cracks Noted. These are typical and generally patch and paint will suffice, however we recommend you monitor these cracks and if they become wider or longer, you will need to contact a structural engineers to assess.

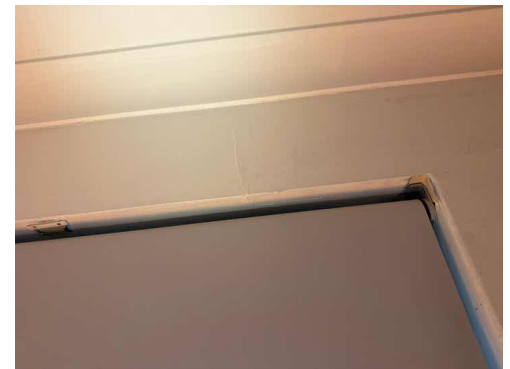
Settlement Cracks Noted. These are typical and generally patch and paint will suffice, however we recommend you monitor these cracks and if they become wider or longer, you will need to contact a structural engineers to assess.

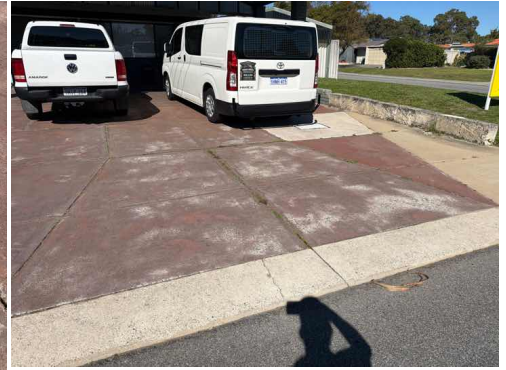
Common cracks were observed on the driveway. Whilst these cracks appeared to be typical at the time of inspection, we strongly recommend you monitor these cracks and if worsening occurs contact a concreter for further advice.

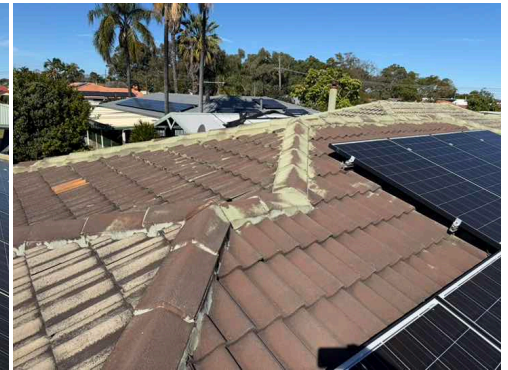
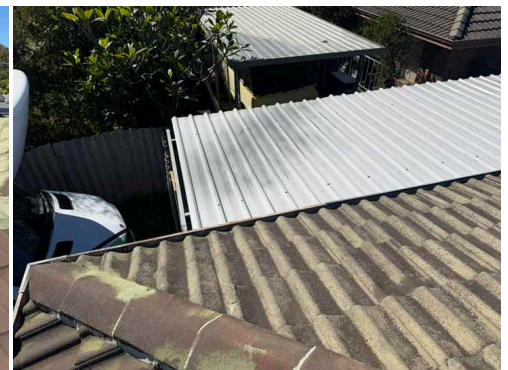
Of the visible areas, the general condition of the roof is in serviceable condition for the age.  
 Note: In the absence of rainfall there is no guarantee that the roof won't leak.  
 Some pointing required minor maintenance issues

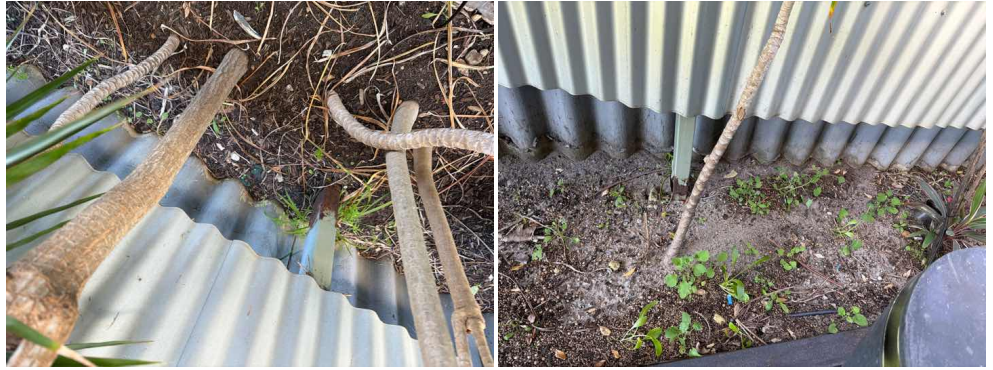
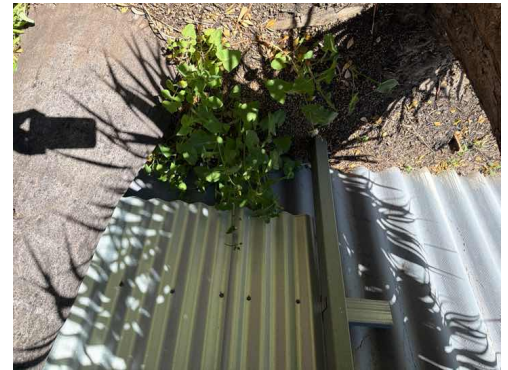
Bottom of meta posts concealed in the ground rust is evident maintenance issues

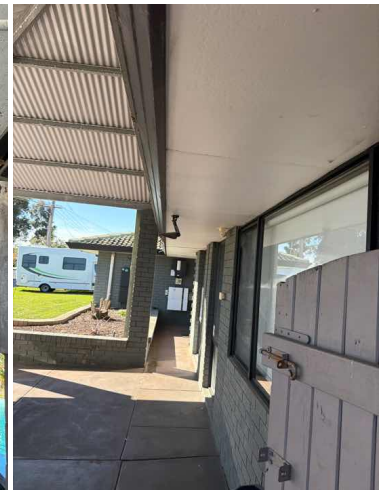
Minor eave deterioration & ageing evident.

Eave lining stains observed. Normally this occurs due to overflow in blocked gutters. Recommendations.

Recommendations: Maintenance works, general upkeep should be carried out.

Gutters should be kept clear of debris and eave linings can then be painted or repaired as required.

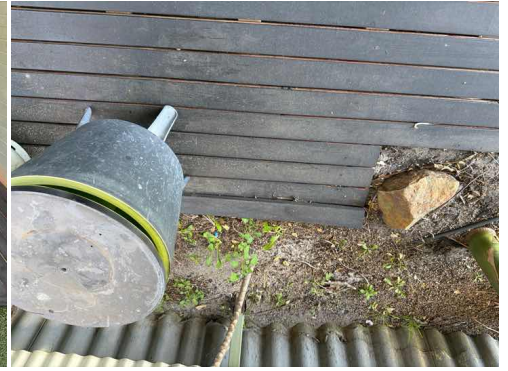
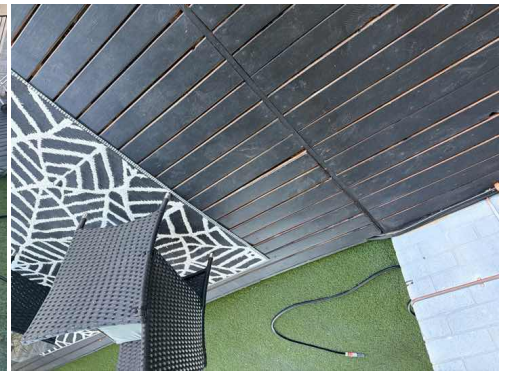
On inspection, defects were present that will require further assessing and recommendations by licensed and qualified trades persons, please read below for details. Some boards loose some brown wood rot weathering maintenance issues
