Inspection Report

Property Services Group WA

Dianella, WA, Australia

Building Inspection

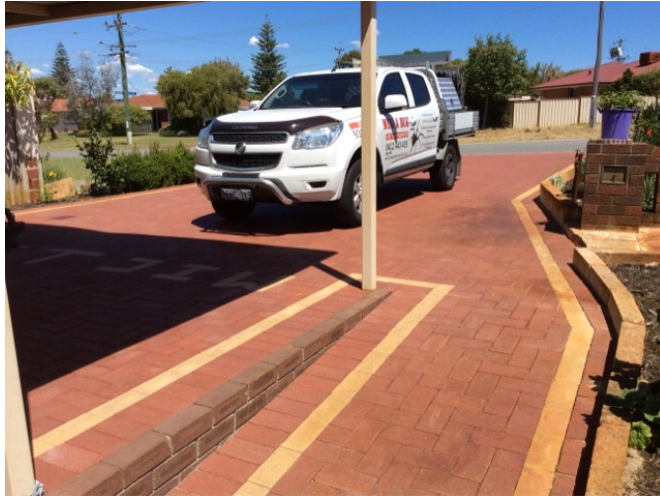
Driveway Condition

On visual inspection, the general condition of the driveway is in a serviceable condition.

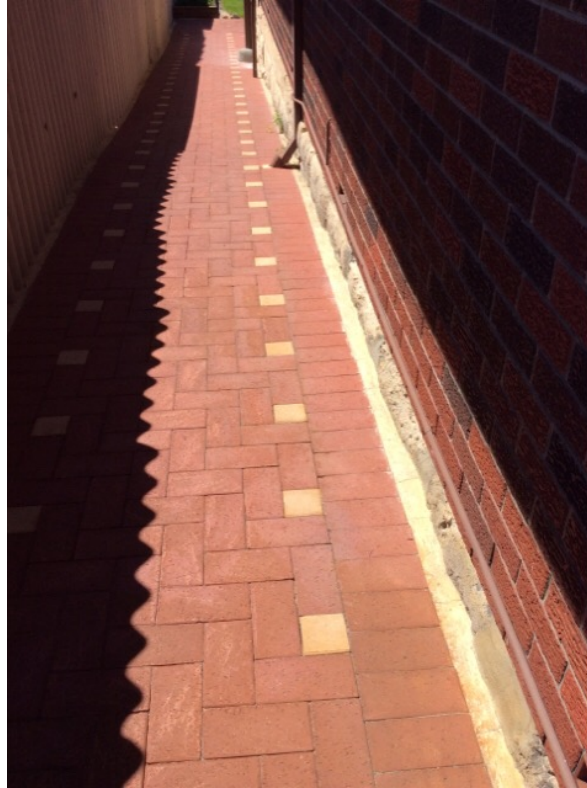
Pathways Condition

The paths around the home are in a serviceable condition for the age of this dwelling with no major defects visible.

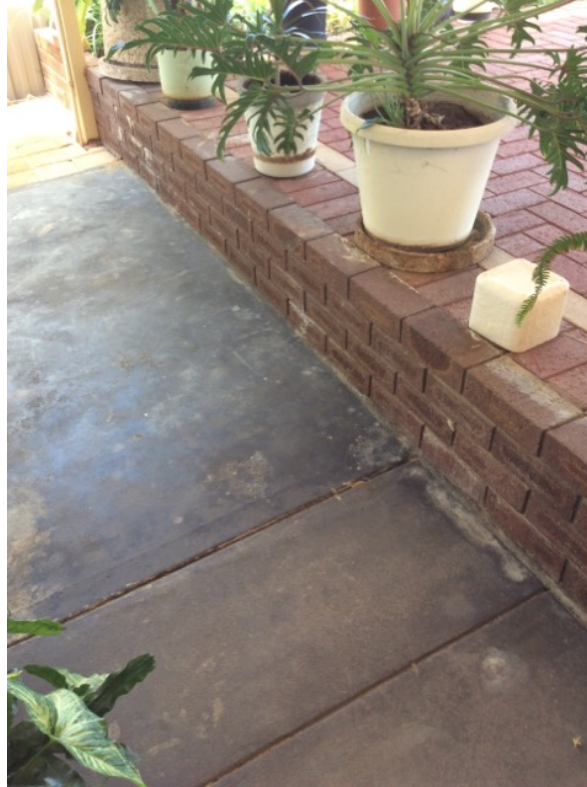
The retaining wall material is brick.

Of the visible areas, the general condition is serviceable or in reasonable condition for age of dwelling.

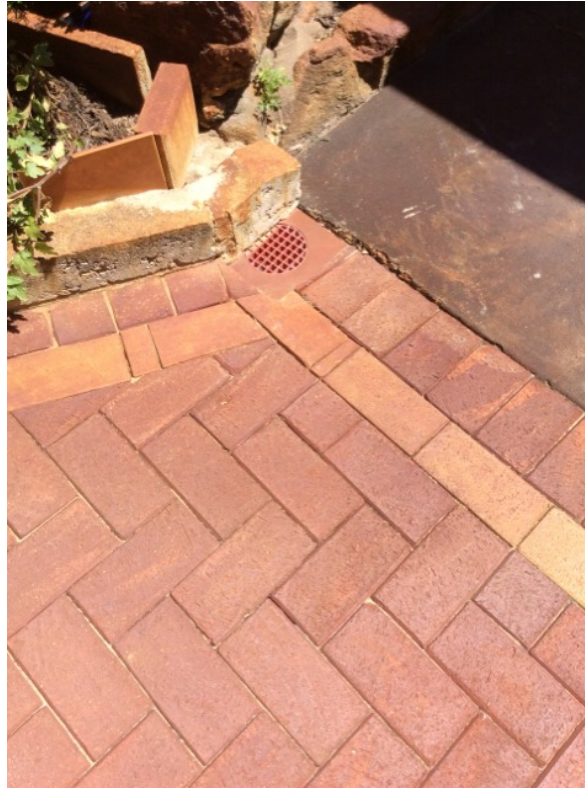
Drainage Findings

There was no visible evidence of excess ponding or fall towards the property walls at the time of the inspection. Regardless, it is difficult to ascertain in dry conditions and it is therefore recommended that you assess same after a rainfall period to be able to sufficiently ascertain if any problems exist in this regard. If water is ponding around perimeter walls and paths or appears to be flowing into the footings/foundations you must have assessed by a qualified plumber or landscaper.

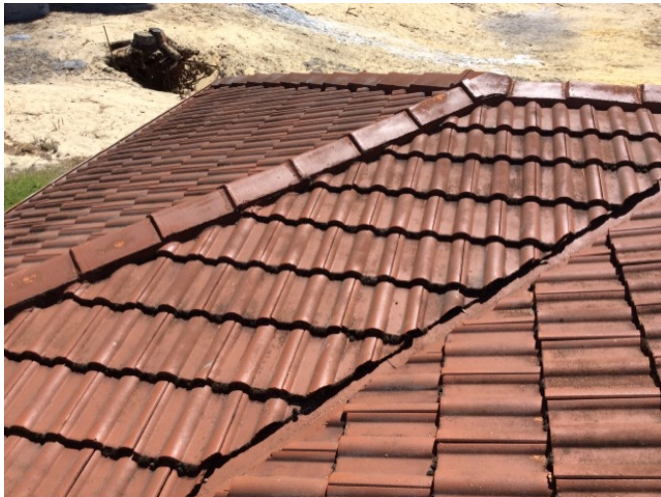
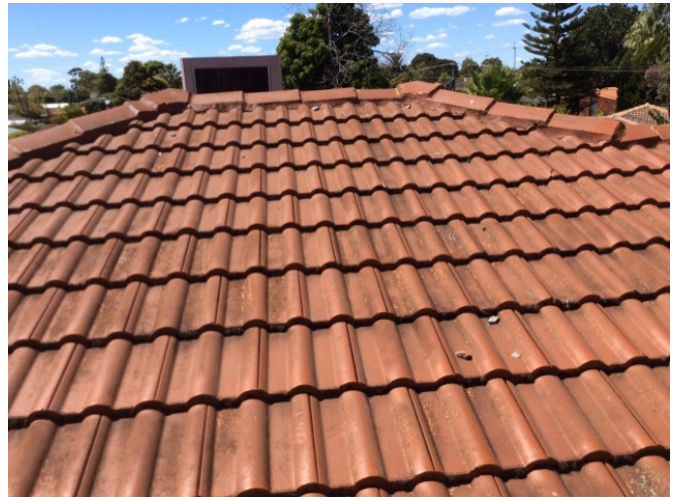
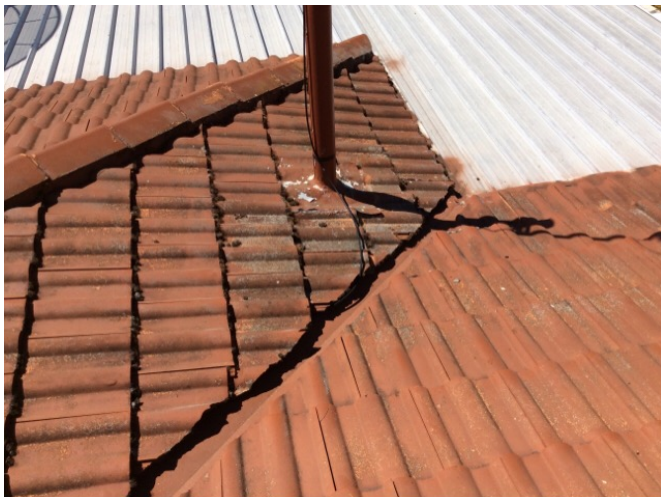
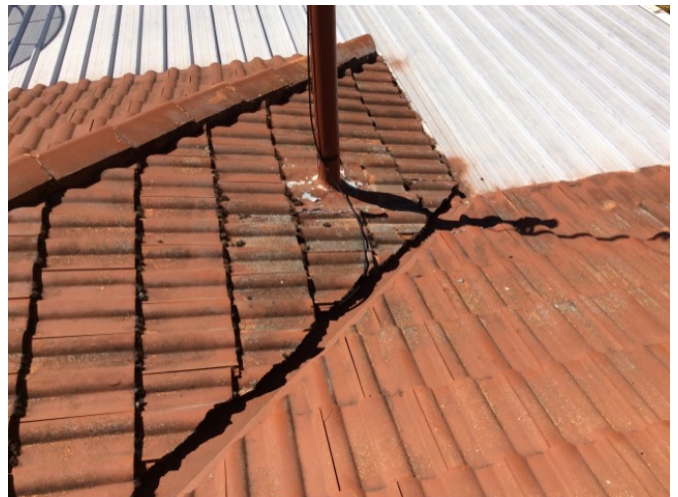
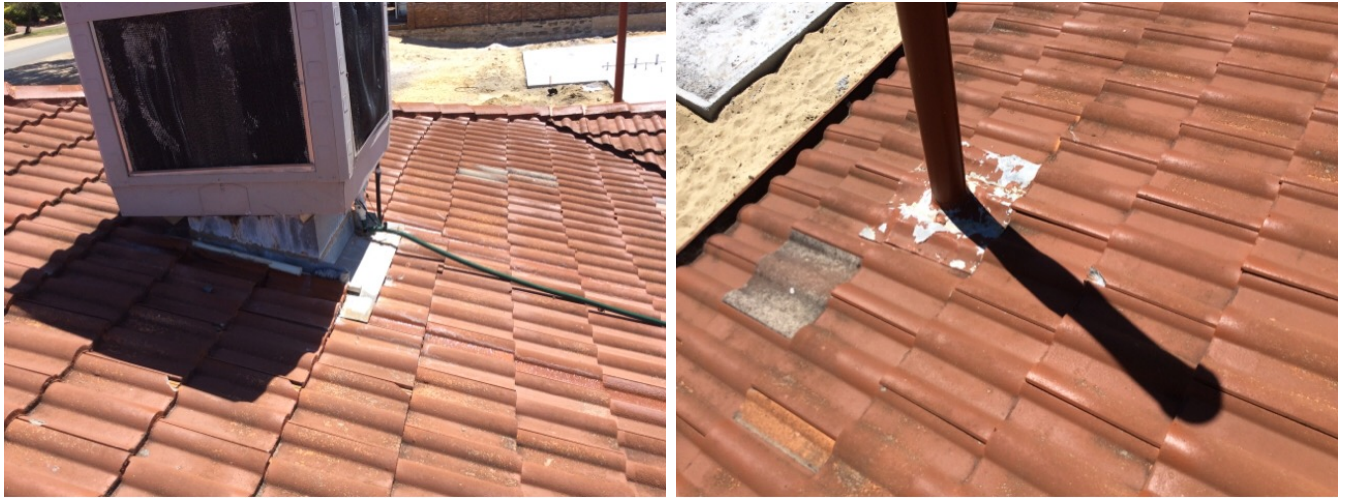
Roof Clad Condition

Visible section of The roof cladding appeared in a serviceable condition for the age of this dwelling. Annual maintenance inspection recommended.

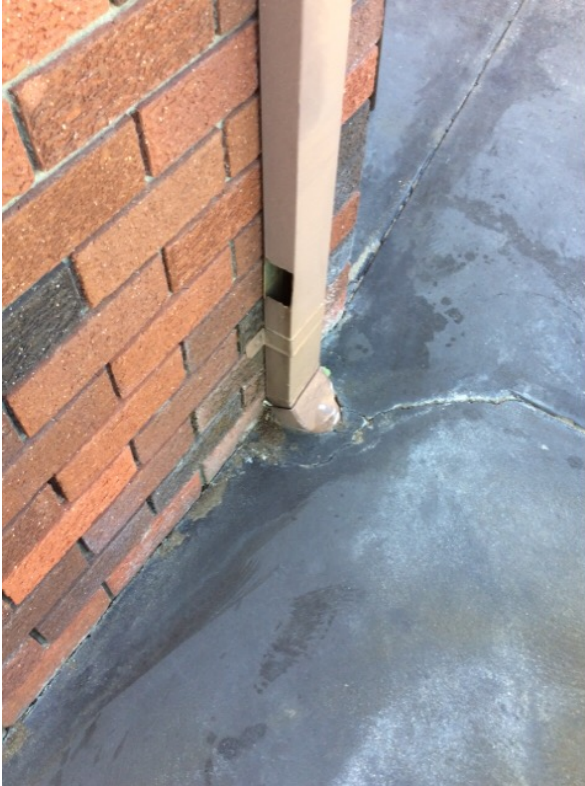
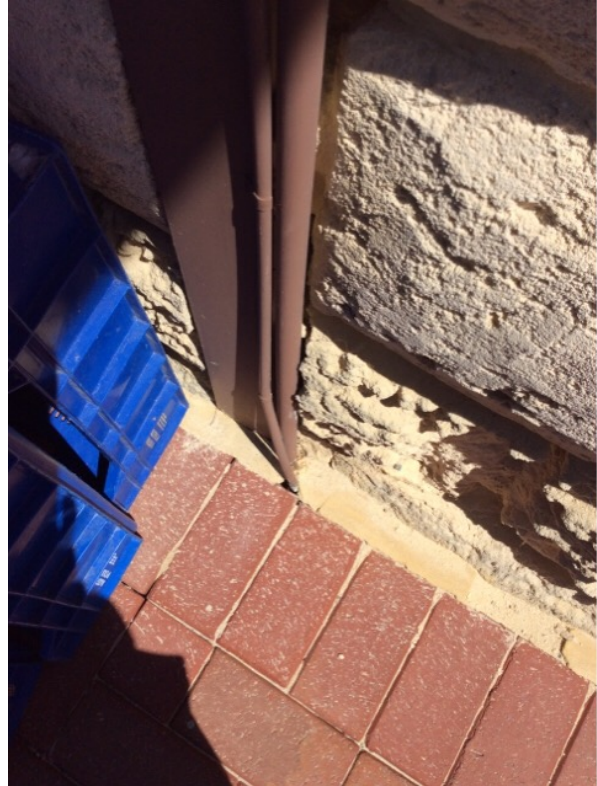
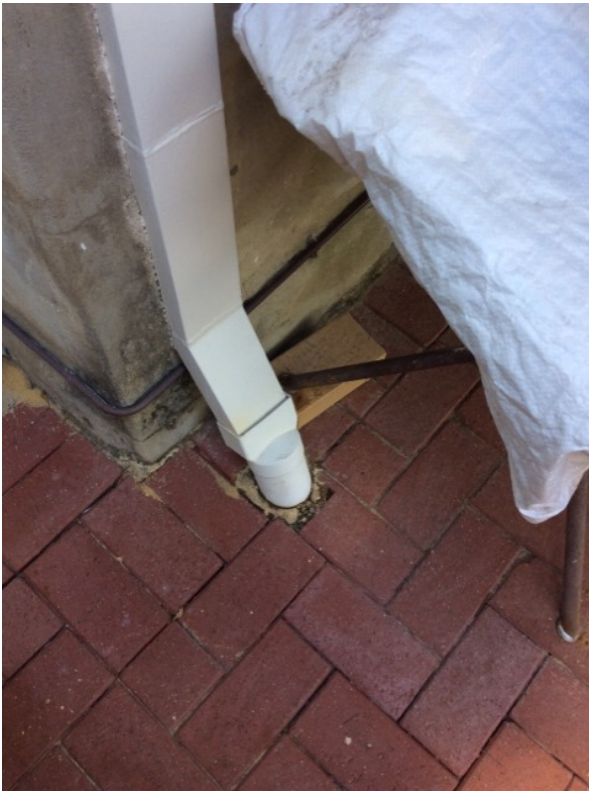
Down Pipe Findings

On visual inspection no apparent defects were noted to the down pipes and are considered serviceable, however no comment can be made with regard to blockages, connections to stormwater or functionality in the absence of rain. Note: Periodic maintenance checks should be carried out for rust penetrations and leaks.

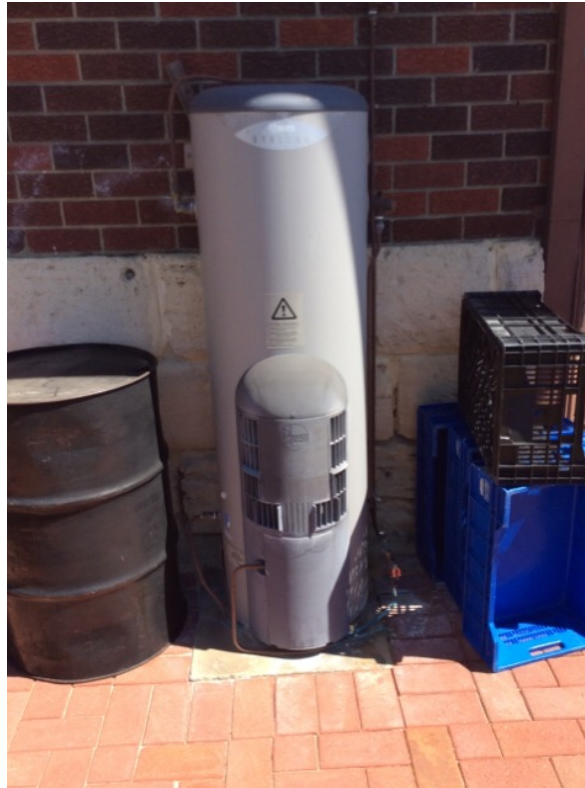
Hot Water Unit Findings

The hot water system appears to be in a serviceable condition. No specific tests other than running the hot water from a tap was carried out. No determination has been made as to the suitability or adequacy of the hot water system in relation to capacity or otherwise.

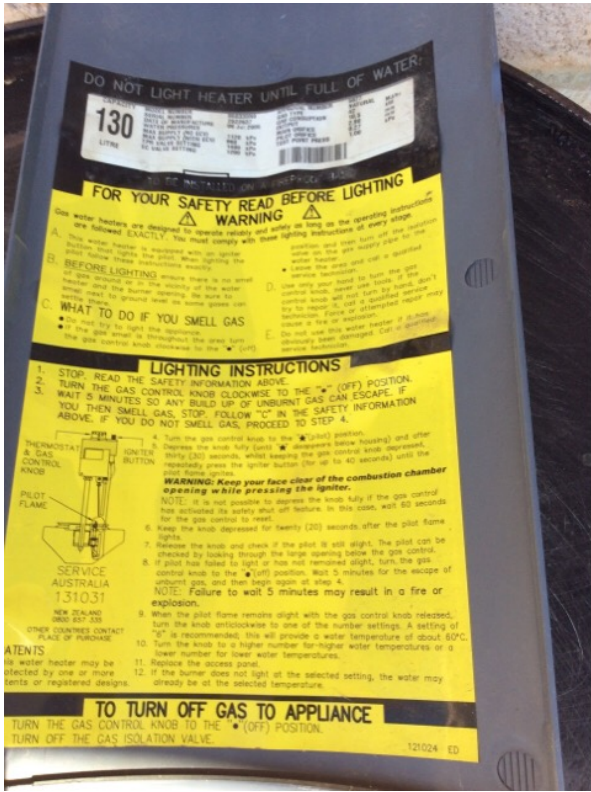
System Make

The make of the hot water unit is rheem.

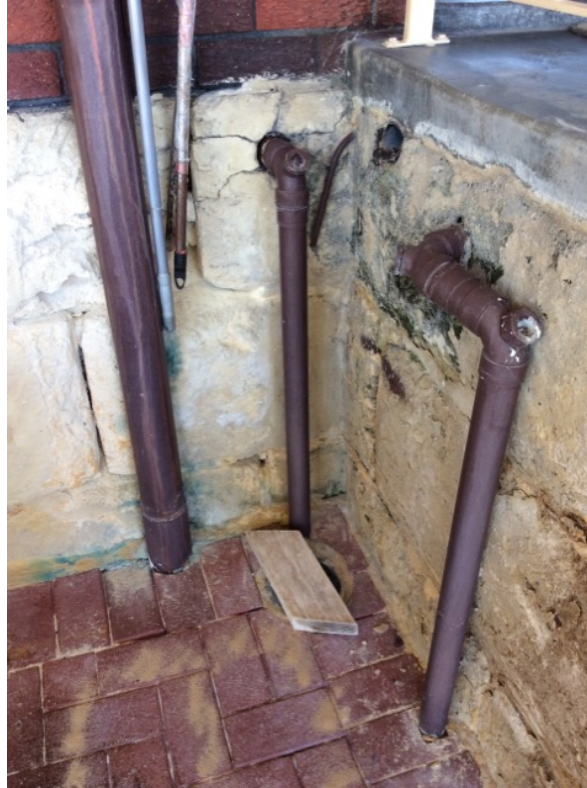
Plumbing Pipes

On Visual inspection the external plumbing pipes appear serviceable , but should be checked by a qualified plumber.

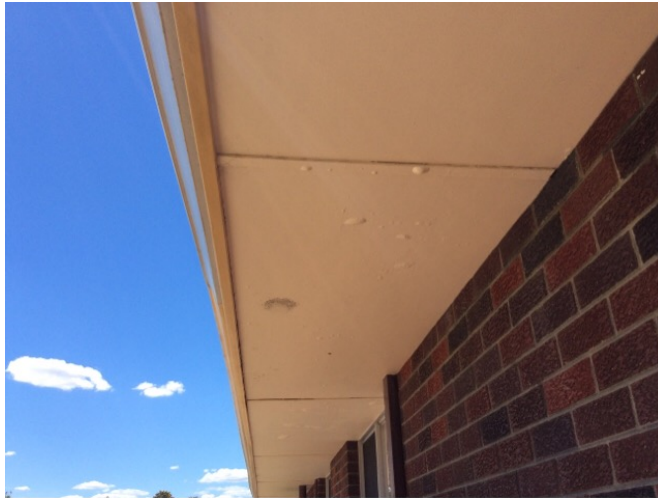
Eave Condition

The eaves are in a serviceable condition with no notable defects.

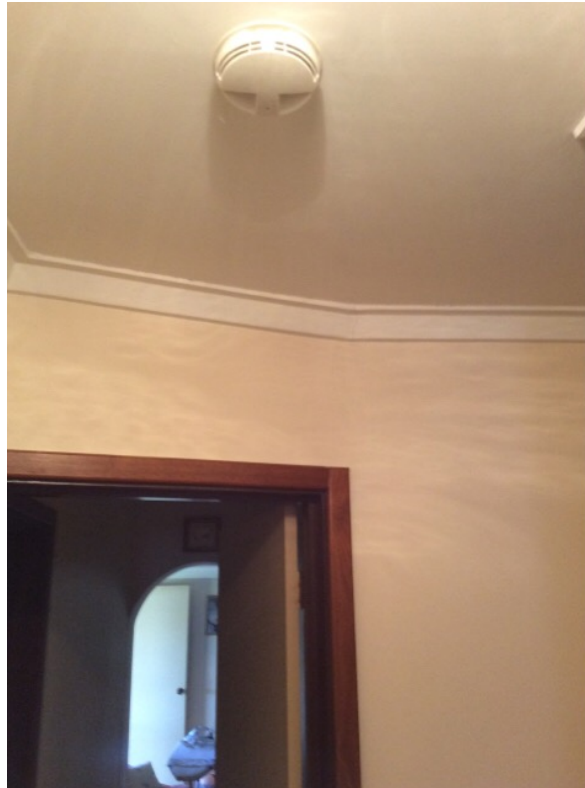
Yes a smoke alarm was sighted but not tested.

All dwellings must have at least one working smoke alarm (sometimes mistakenly referred to as “smoke detectors”) installed on each level of their home. This includes owner occupied, rental properties, relocatable homes or any other residential building where people sleep. We strongly recommend you have a least 1 working smoke alarm installed.
