# Inspection Report

**Property Services Group WA Pty Ltd T/A Building & Pest Services WA**

**17 Grainger way thornlie, Perth, Wa, 6108**

| Report/Agreement # | 290726012827506 |

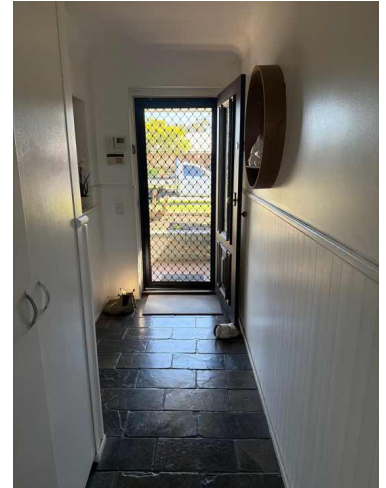
Settlement Cracks Noted. These are typical and generally patch and paint will suffice, however monitoring these cracks is advised for 12 months and if they become worse, further investigation by a suitably qualified professional is advised.

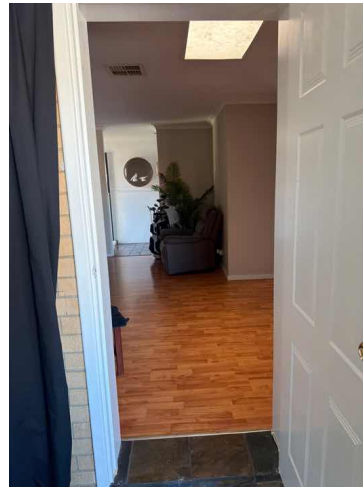
Doorway created in cavity brick wall no visual evidence of any cracks to walls

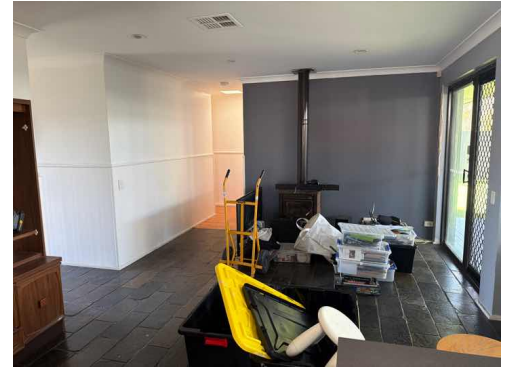
Settlement Cracks Noted. These are typical and generally patch and paint will suffice, however monitoring these cracks is advised for 12 months and if they become worse, further investigation by a suitably qualified professional is advised.

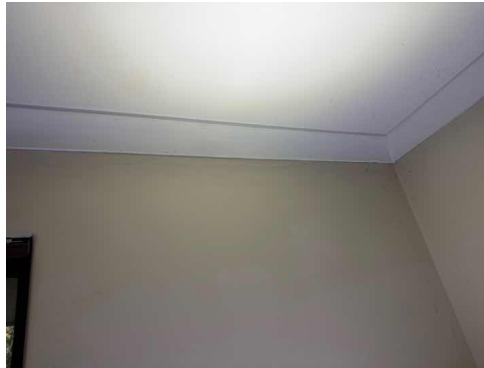
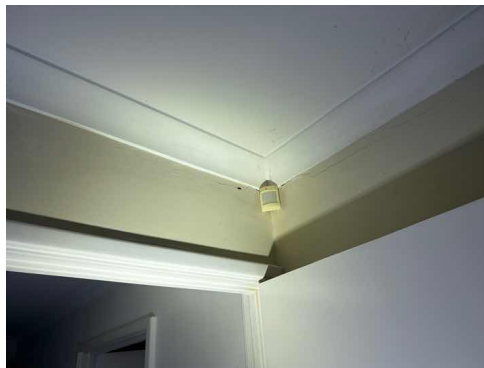
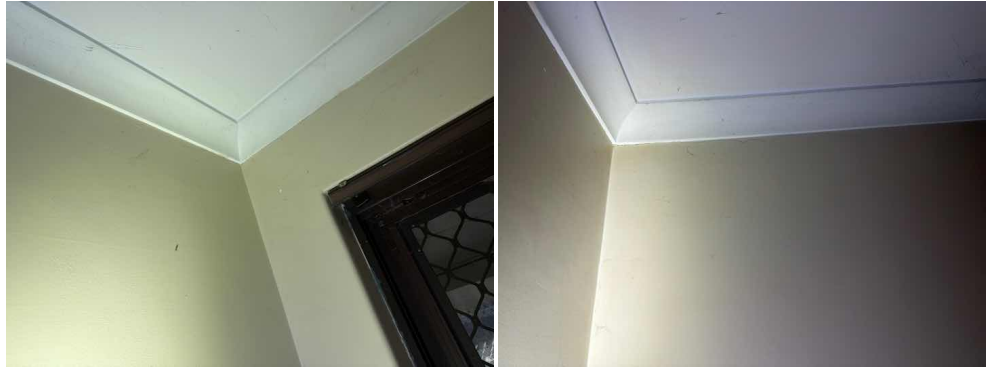
Settlement Cracks Noted. These are typical and generally patch and paint will suffice, however we recommend you monitor these cracks and if they become wider or longer, you will need to contact a structural engineers to assess.

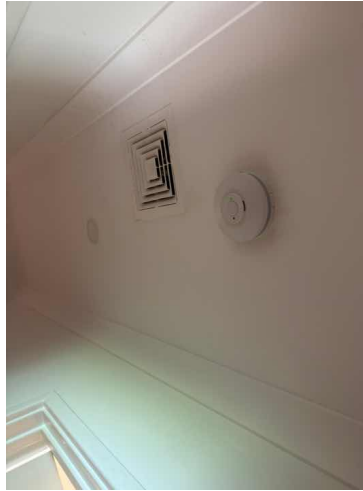
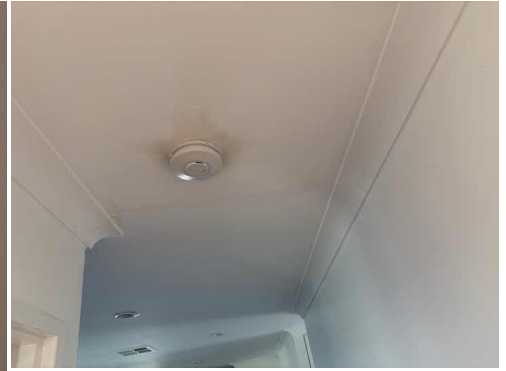
Yes 2 smoke alarms were sighted but not tested.

Legislation requires smoke Alarms to be installed. Check with your local council regarding type, locations and other related requirements.

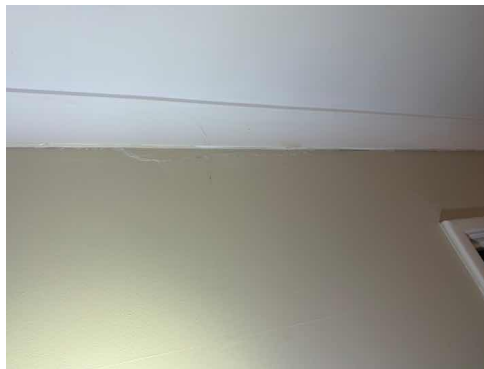
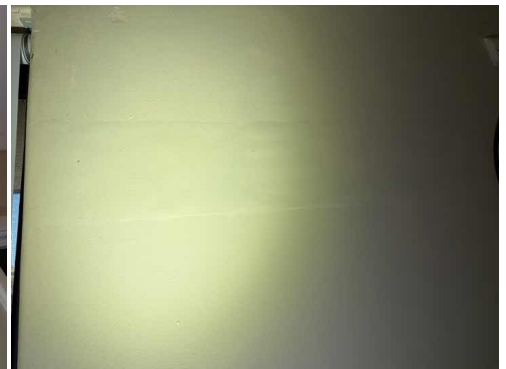
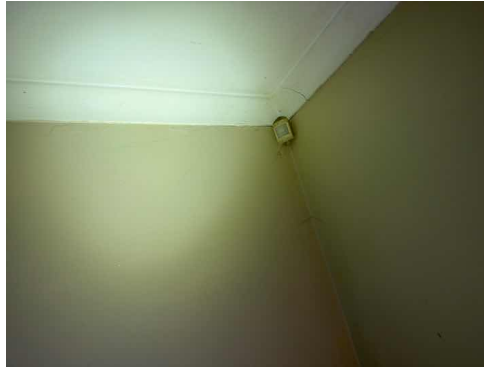
Settlement Cracks Noted. These are typical and generally patch and paint will suffice, however we recommend you monitor these cracks and if they become wider or longer, you will need to contact a structural engineers to assess.

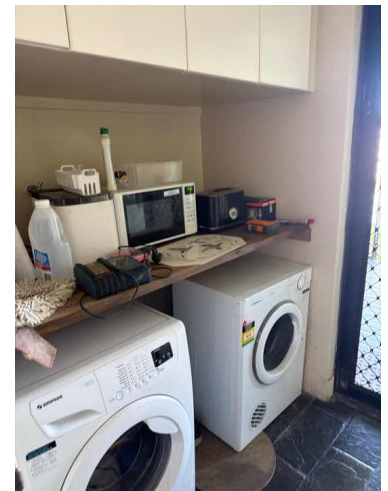
Of the visible areas, the general condition of the laundry is serviceable or in reasonable condition for age of dwelling.

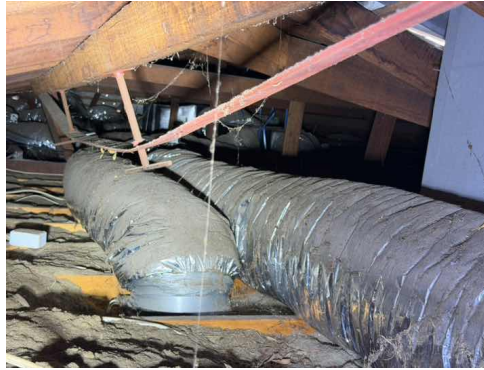
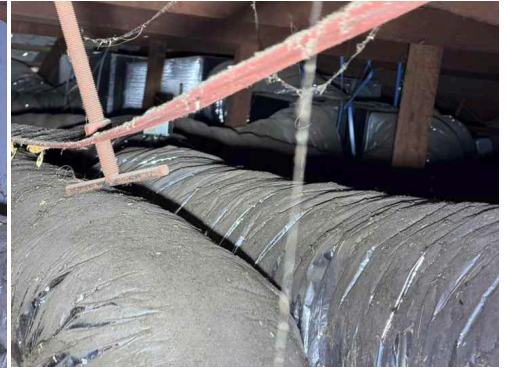
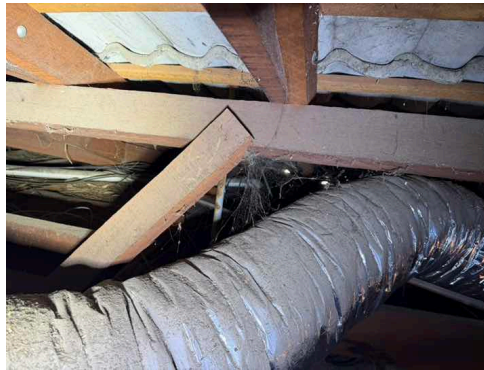
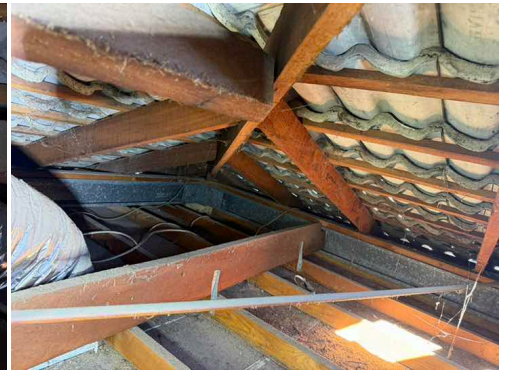
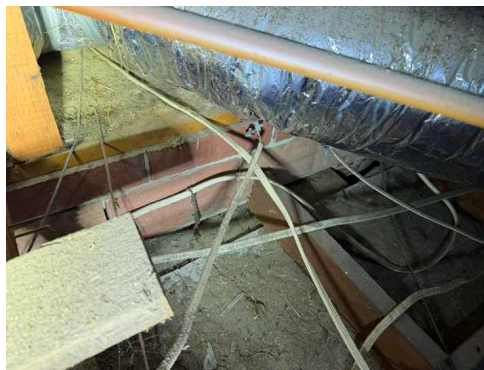
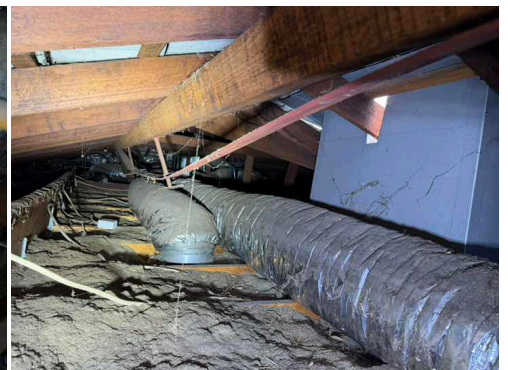
The roof frame is a conventional timber frame.

**Roof Framing** The dwelling was constructed in approximately 1983 and incorporates a conventional timber-framed, concrete tiled roof. The accessible roof void was inspected. Inspection was significantly restricted by extensive insulated air-conditioning ductwork, limiting access and preventing a complete assessment of all roof framing members. The following observations were noted within the accessible areas: Butt-jointed timber strutting was observed. Lazy strutting was present. Metal tension straps roof restraint was installed. Some under purlins appear to be over-spanning when assessed against current construction practices. Solar photovoltaic panels have been installed to the roof, increasing the dead load imposed on the roof structure. Due to the extensive ductwork, it was not possible to inspect all framing members or confirm the full extent of roof restraint and framing details. No significant deflection, distortion or evidence of imminent structural failure was observed to the accessible roof framing at the time of inspection. Externally, the roof line appeared generally even, with no readily visible evidence of major dips, sagging or deformation.

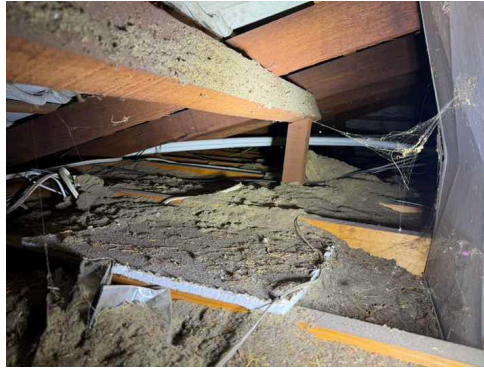
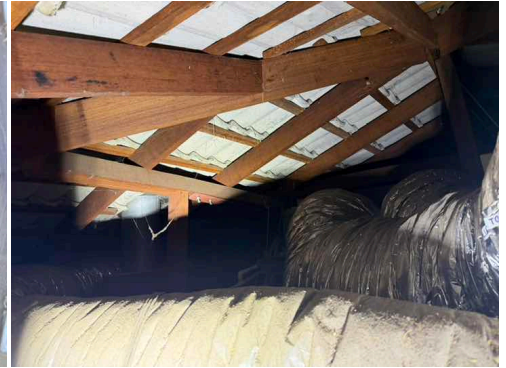
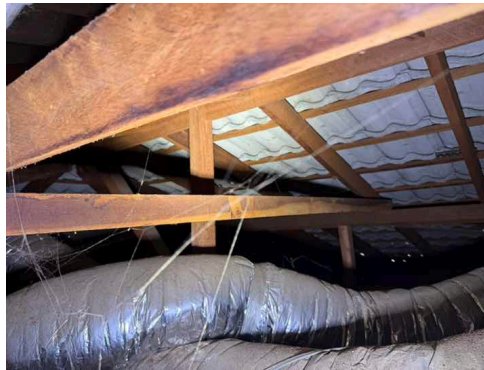
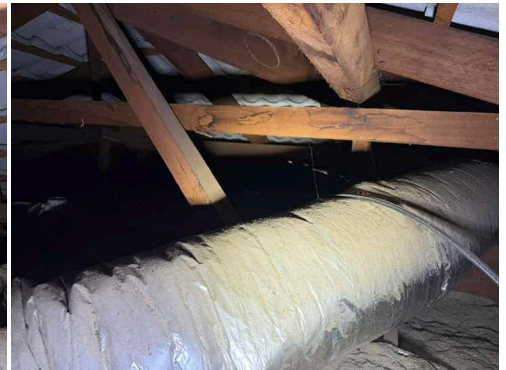
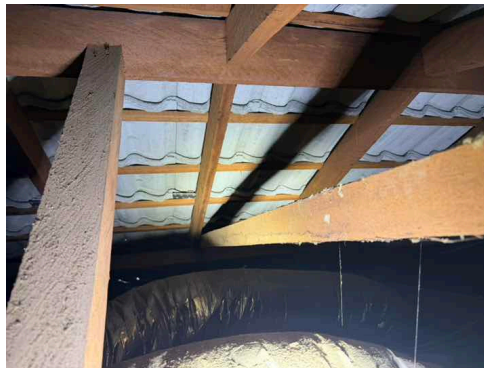
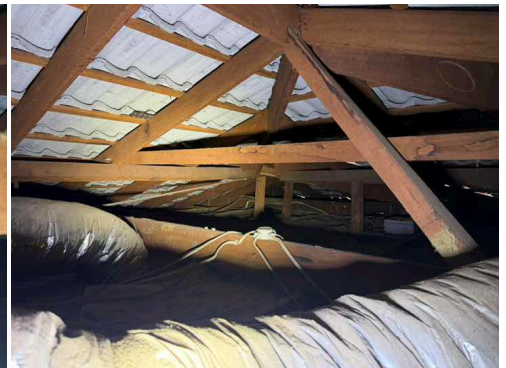
At the time of inspection, no significant structural distortion or movement was observed within accessible areas of the roof void. Assessment is limited to visible conditions only and areas that were safe and reasonably accessible at the time of inspection.

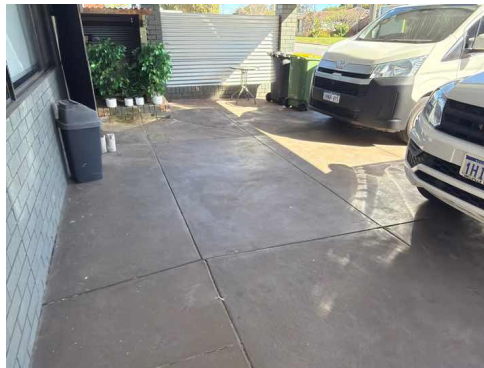
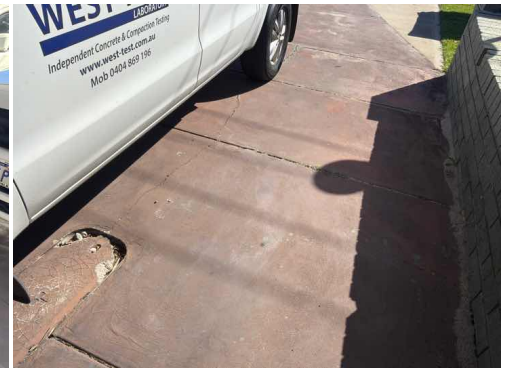
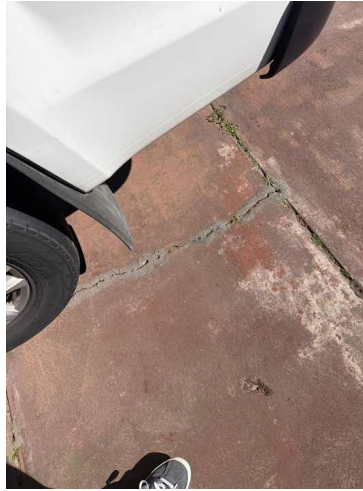
Common cracks were observed on the driveway. Whilst these cracks appeared to be typical at the time of inspection, we strongly recommend you monitor these cracks and if worsening occurs contact a concreter for further advice.

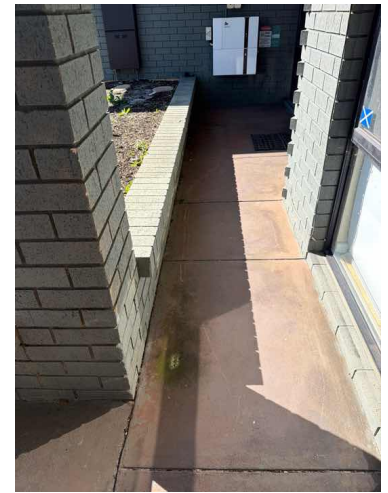
The paths around the home are in a serviceable condition for the age of this dwelling with no major defects visible.

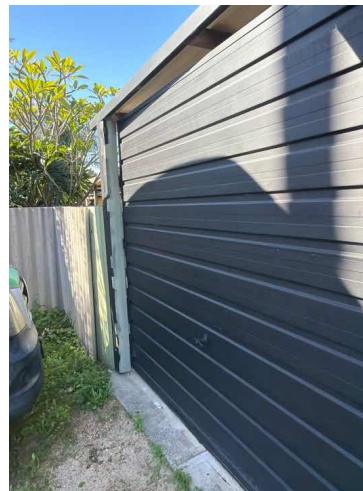
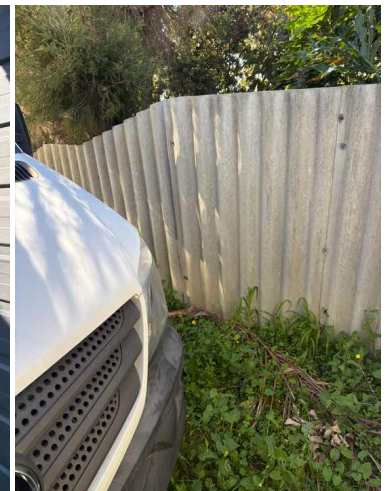
Of the visible areas, the general condition of the fences and gates is serviceable for the age of dwelling.

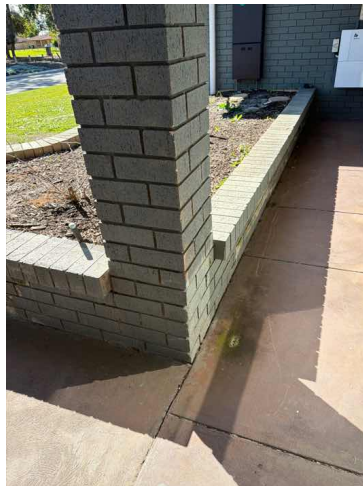
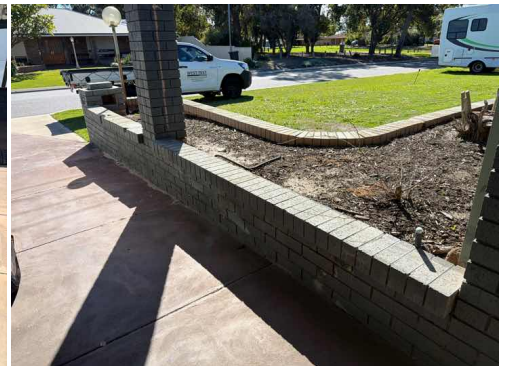
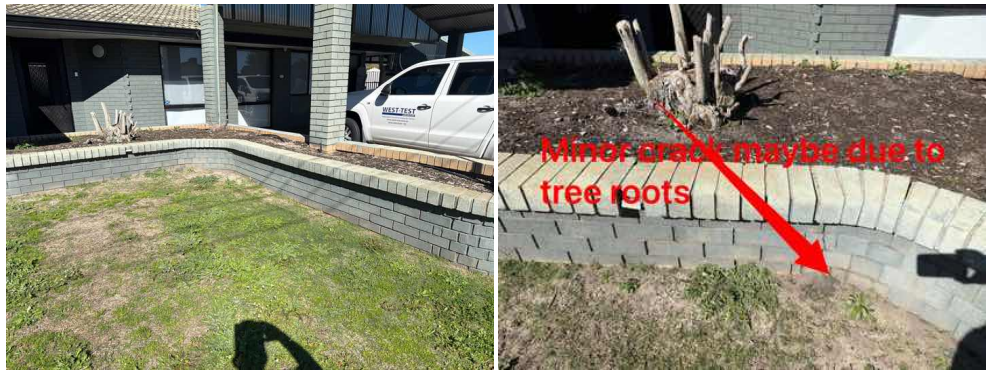
The retaining wall material is brick.

Of the visible areas, the general condition is serviceable or in reasonable condition for age of dwelling.

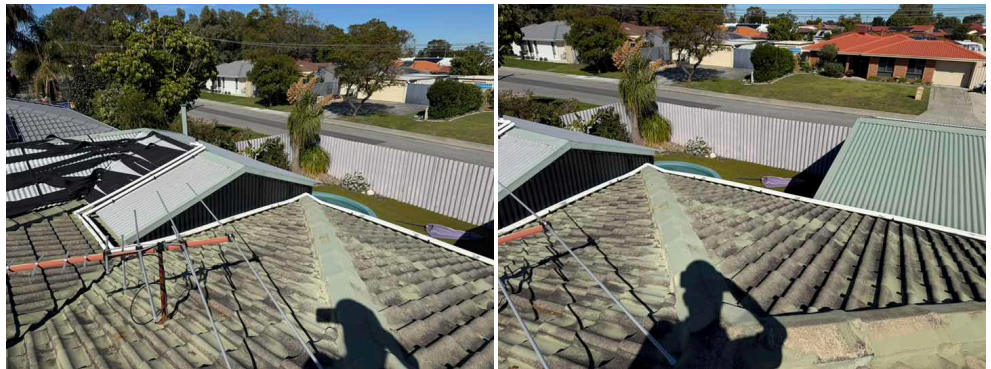
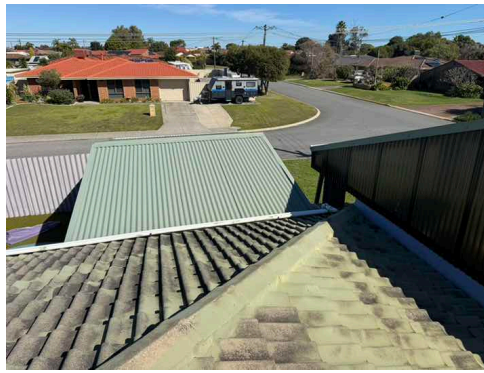
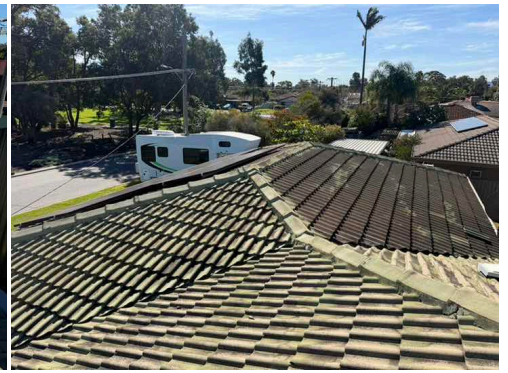
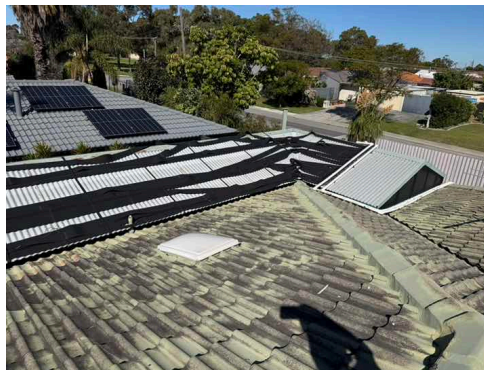
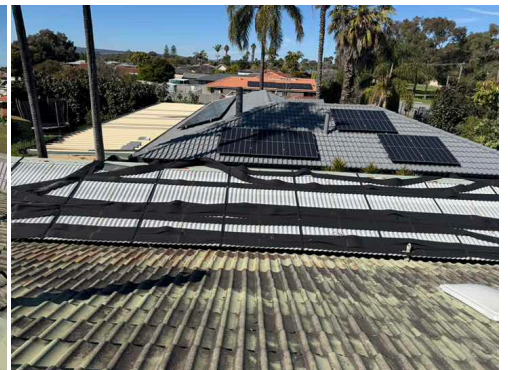
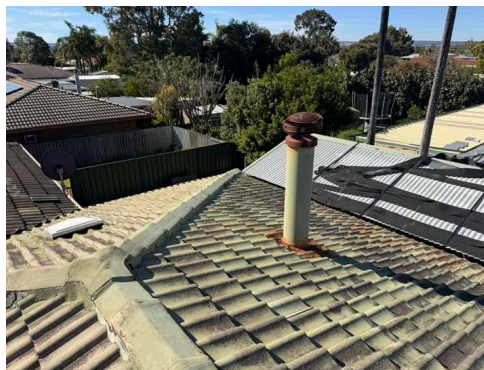
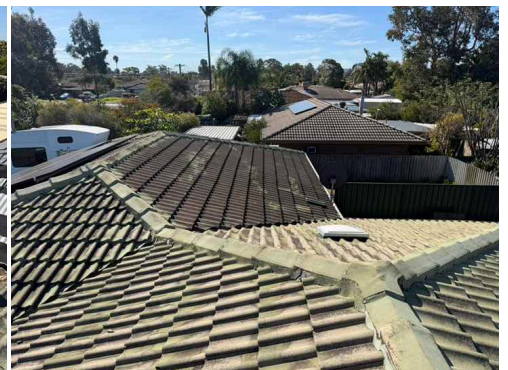
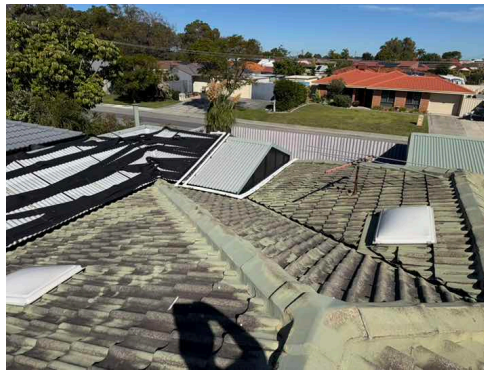
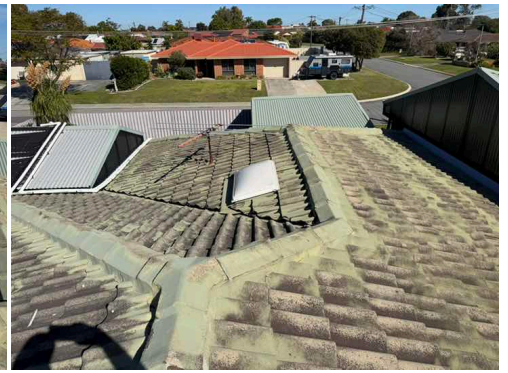
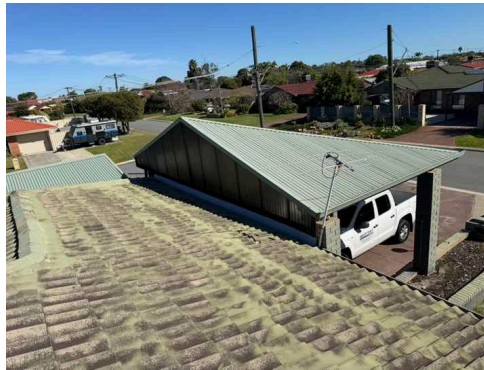
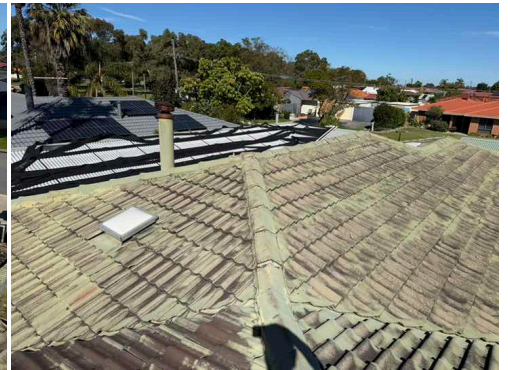
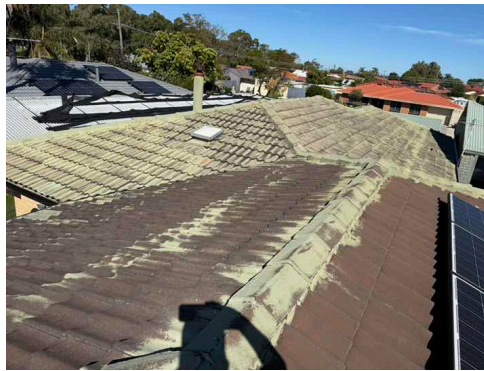
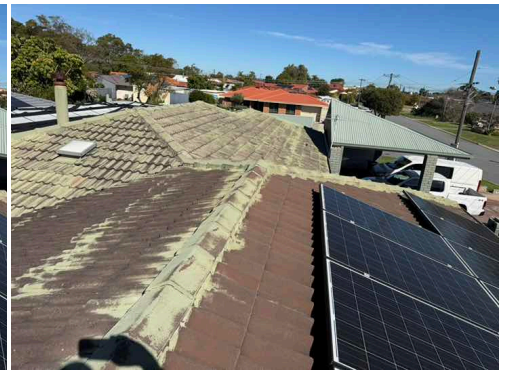
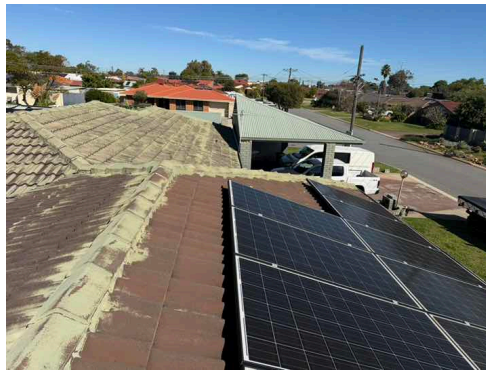
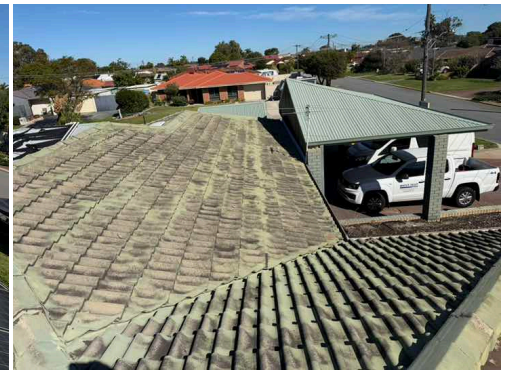
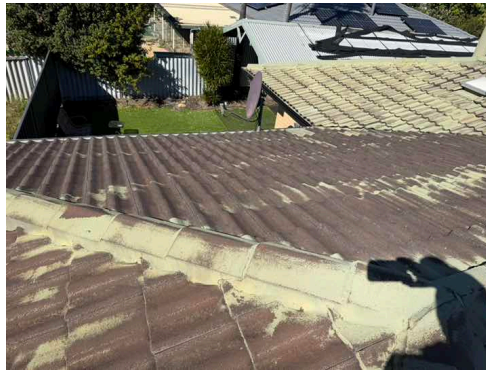
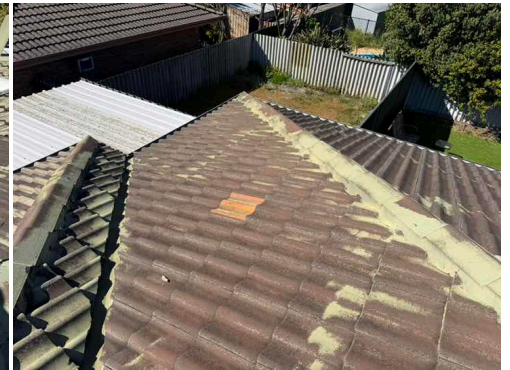
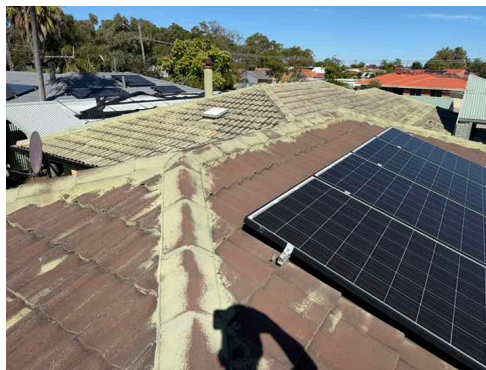
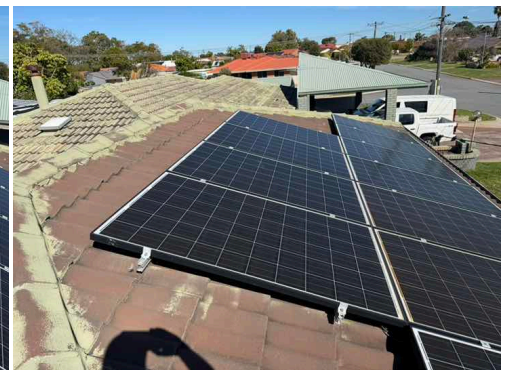
The roof is of concrete tiles.

Of the visible areas, the general condition of the roof is in serviceable condition for the age.  
 Note: In the absence of rainfall there is no guarantee that the roof won't leak.  
 Some pointing required minor maintenance issues

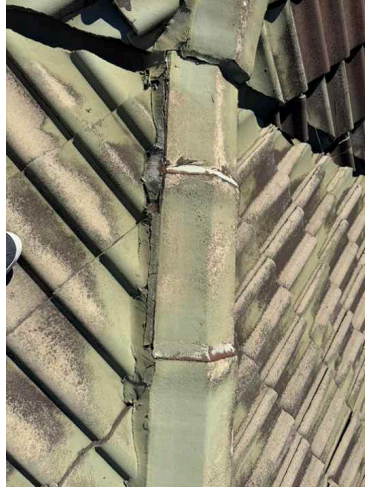
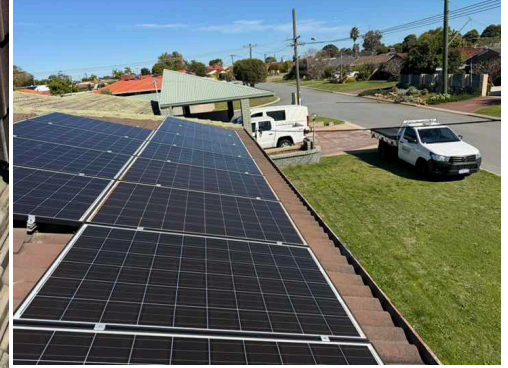
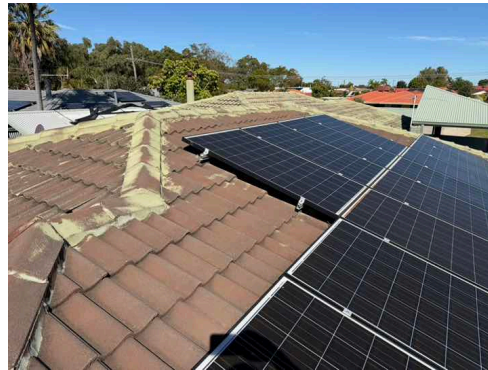
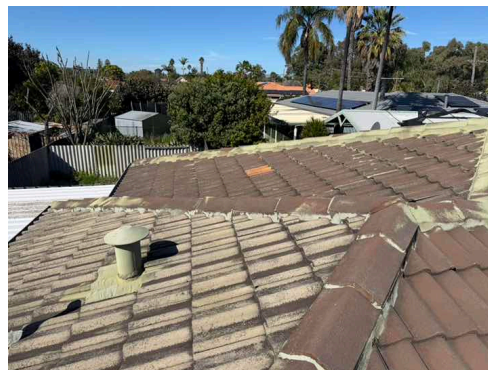
Visible section of The roof cladding appeared in a serviceable condition for the age of this dwelling. Annual maintenance inspection recommended.

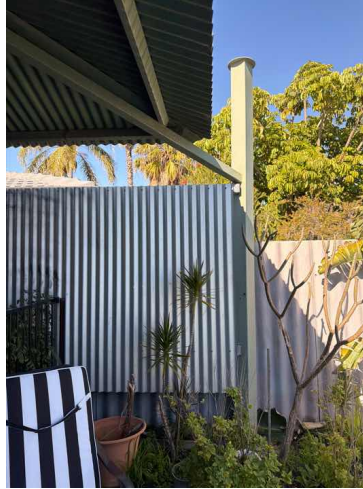
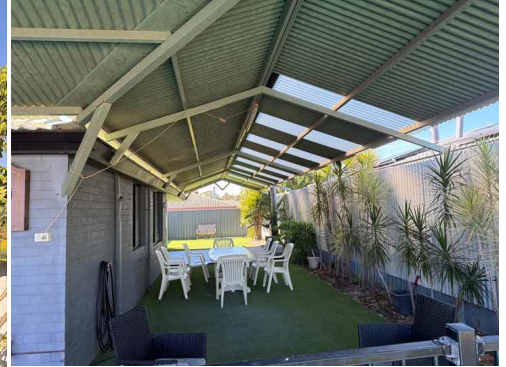
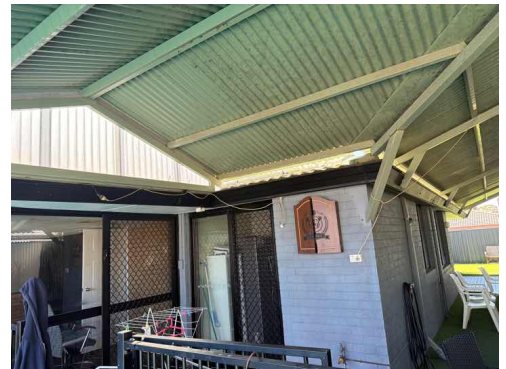
Visible sections of the Alfresco area are serviceable or in reasonable or condition for the age of this dwelling.

Bottom of meta posts concealed in the ground rust is evident maintenance issues

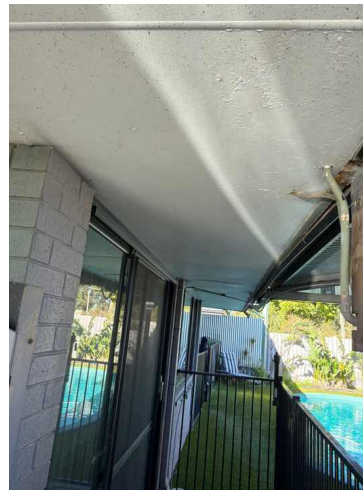
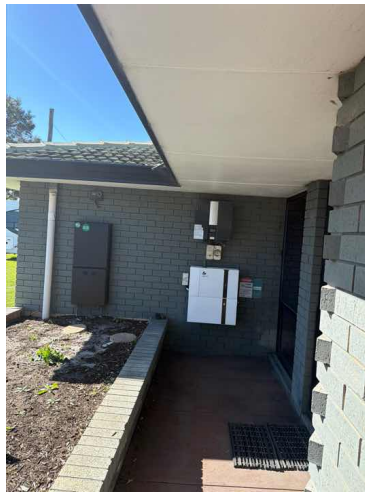
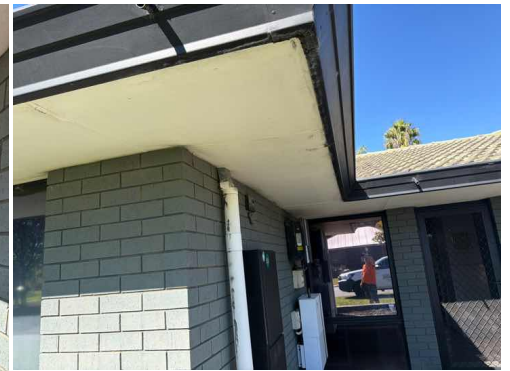
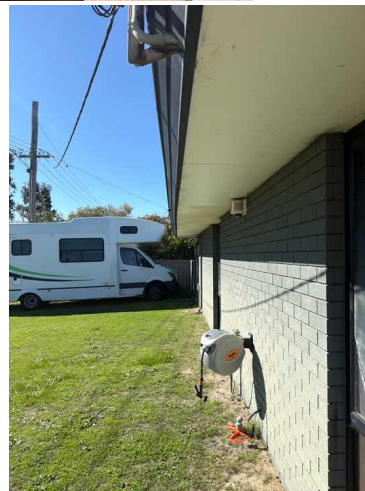
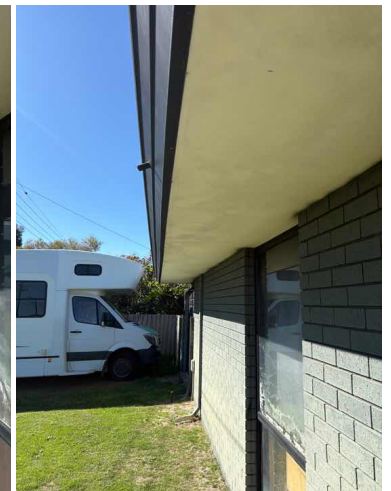
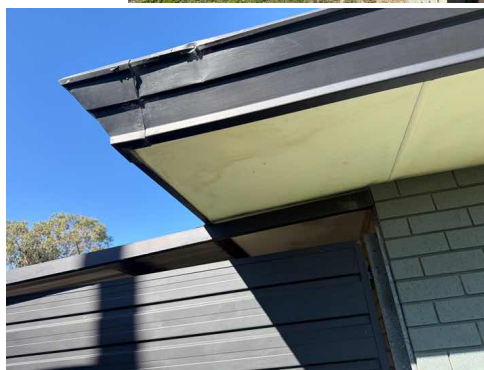
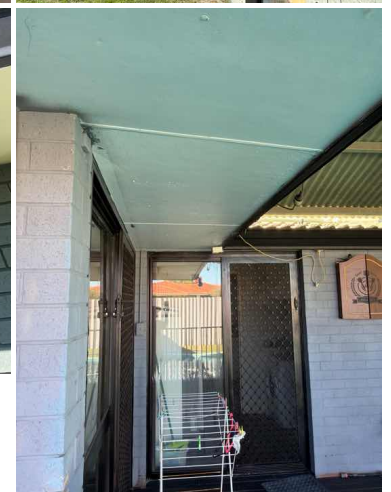
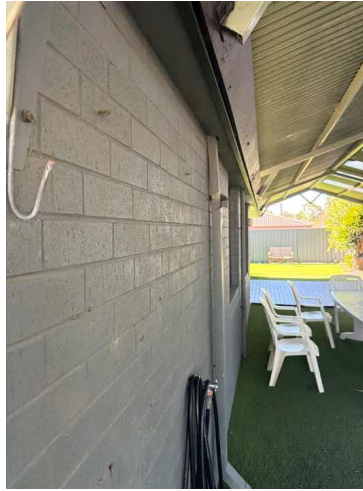
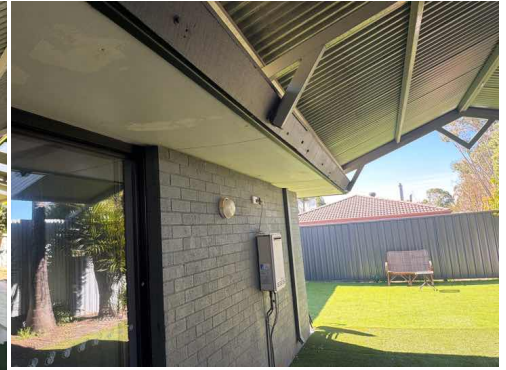
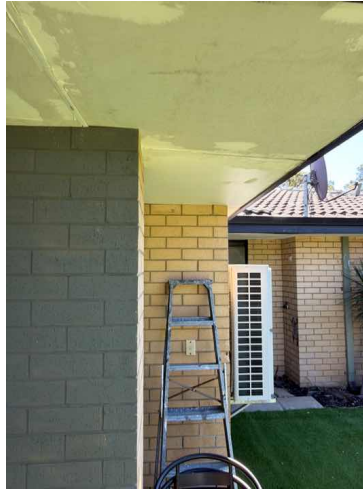
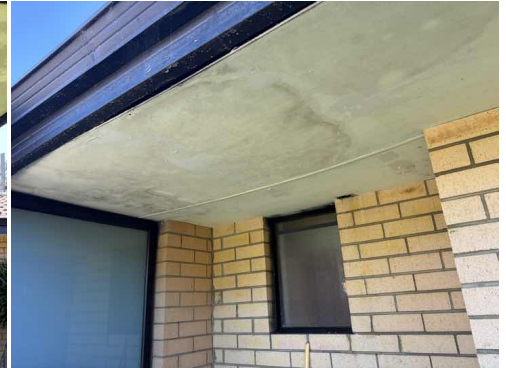
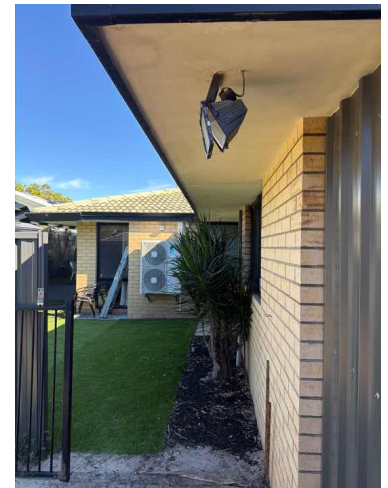
Minor eave deterioration & ageing evident.

Eave lining stains observed. Normally this occurs due to overflow in blocked gutters. Recommendations.

Recommendations: Maintenance works, general upkeep should be carried out.

Gutters should be kept clear of debris and eave linings can then be painted or repaired as required.

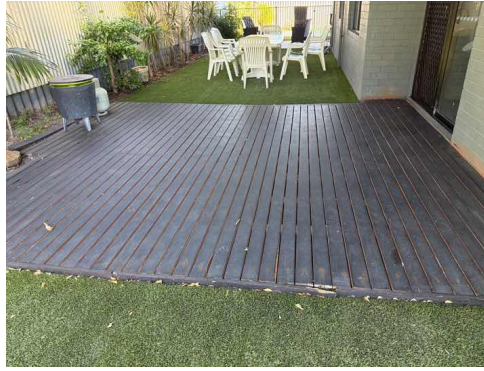
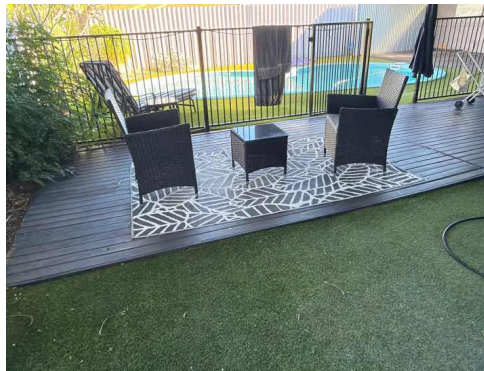
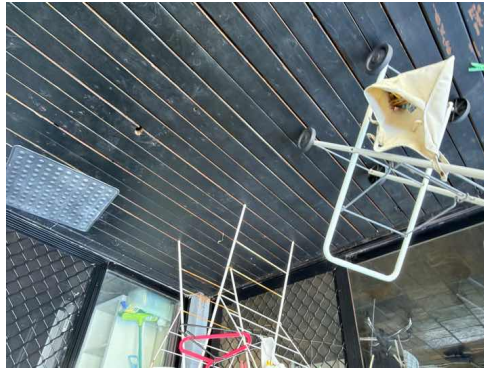
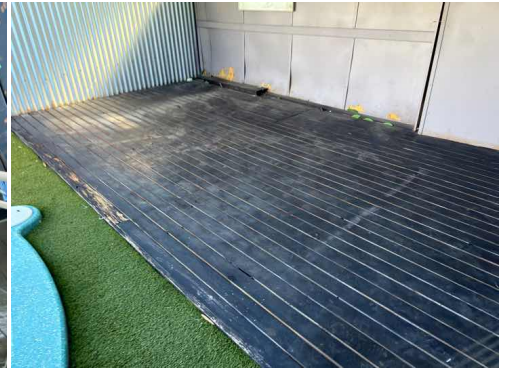
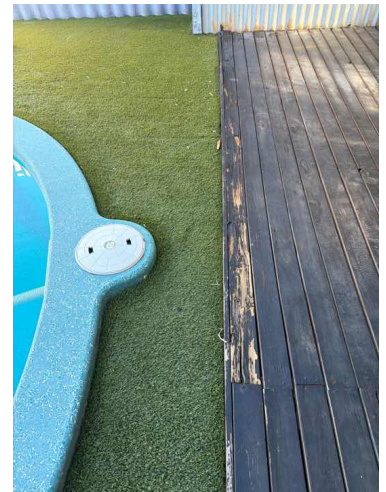
On inspection, defects were present that will require further assessing and recommendations by licensed and qualified trades persons, please read below for details. Some boards loose some brown wood rot weathering maintenance issues
